FIRE TEST REPORT EUI-23-B-000615

According to BS EN 1363-1:2020 and BS EN 1364-1:2016 +A1:2018

Test	EUI-23-B-000615
Performed on	24th October 2023
Regarding	SHAFT-60-I-B-3X15-GFFC-GFFCE One Non-loadbearing wall Unexposed side: One layer of plasterboard reference Glasroc F FireCase 20mm, (BRITISH GYPSUM) Exposed side: Triple layer of plasterboard reference Glasroc F FireCase 15mm, (BRITISH GYPSUM)
Sponsor	Hadley Group Technology (A division of Hadley Sections Ltd) Ltd. P.O Box 92 Downing Street B66 2PA Smethwick, West Midlands UNITED KINGDOM

Reference: SHAFT-60-I-B-3X15-GFFC-GFFCE

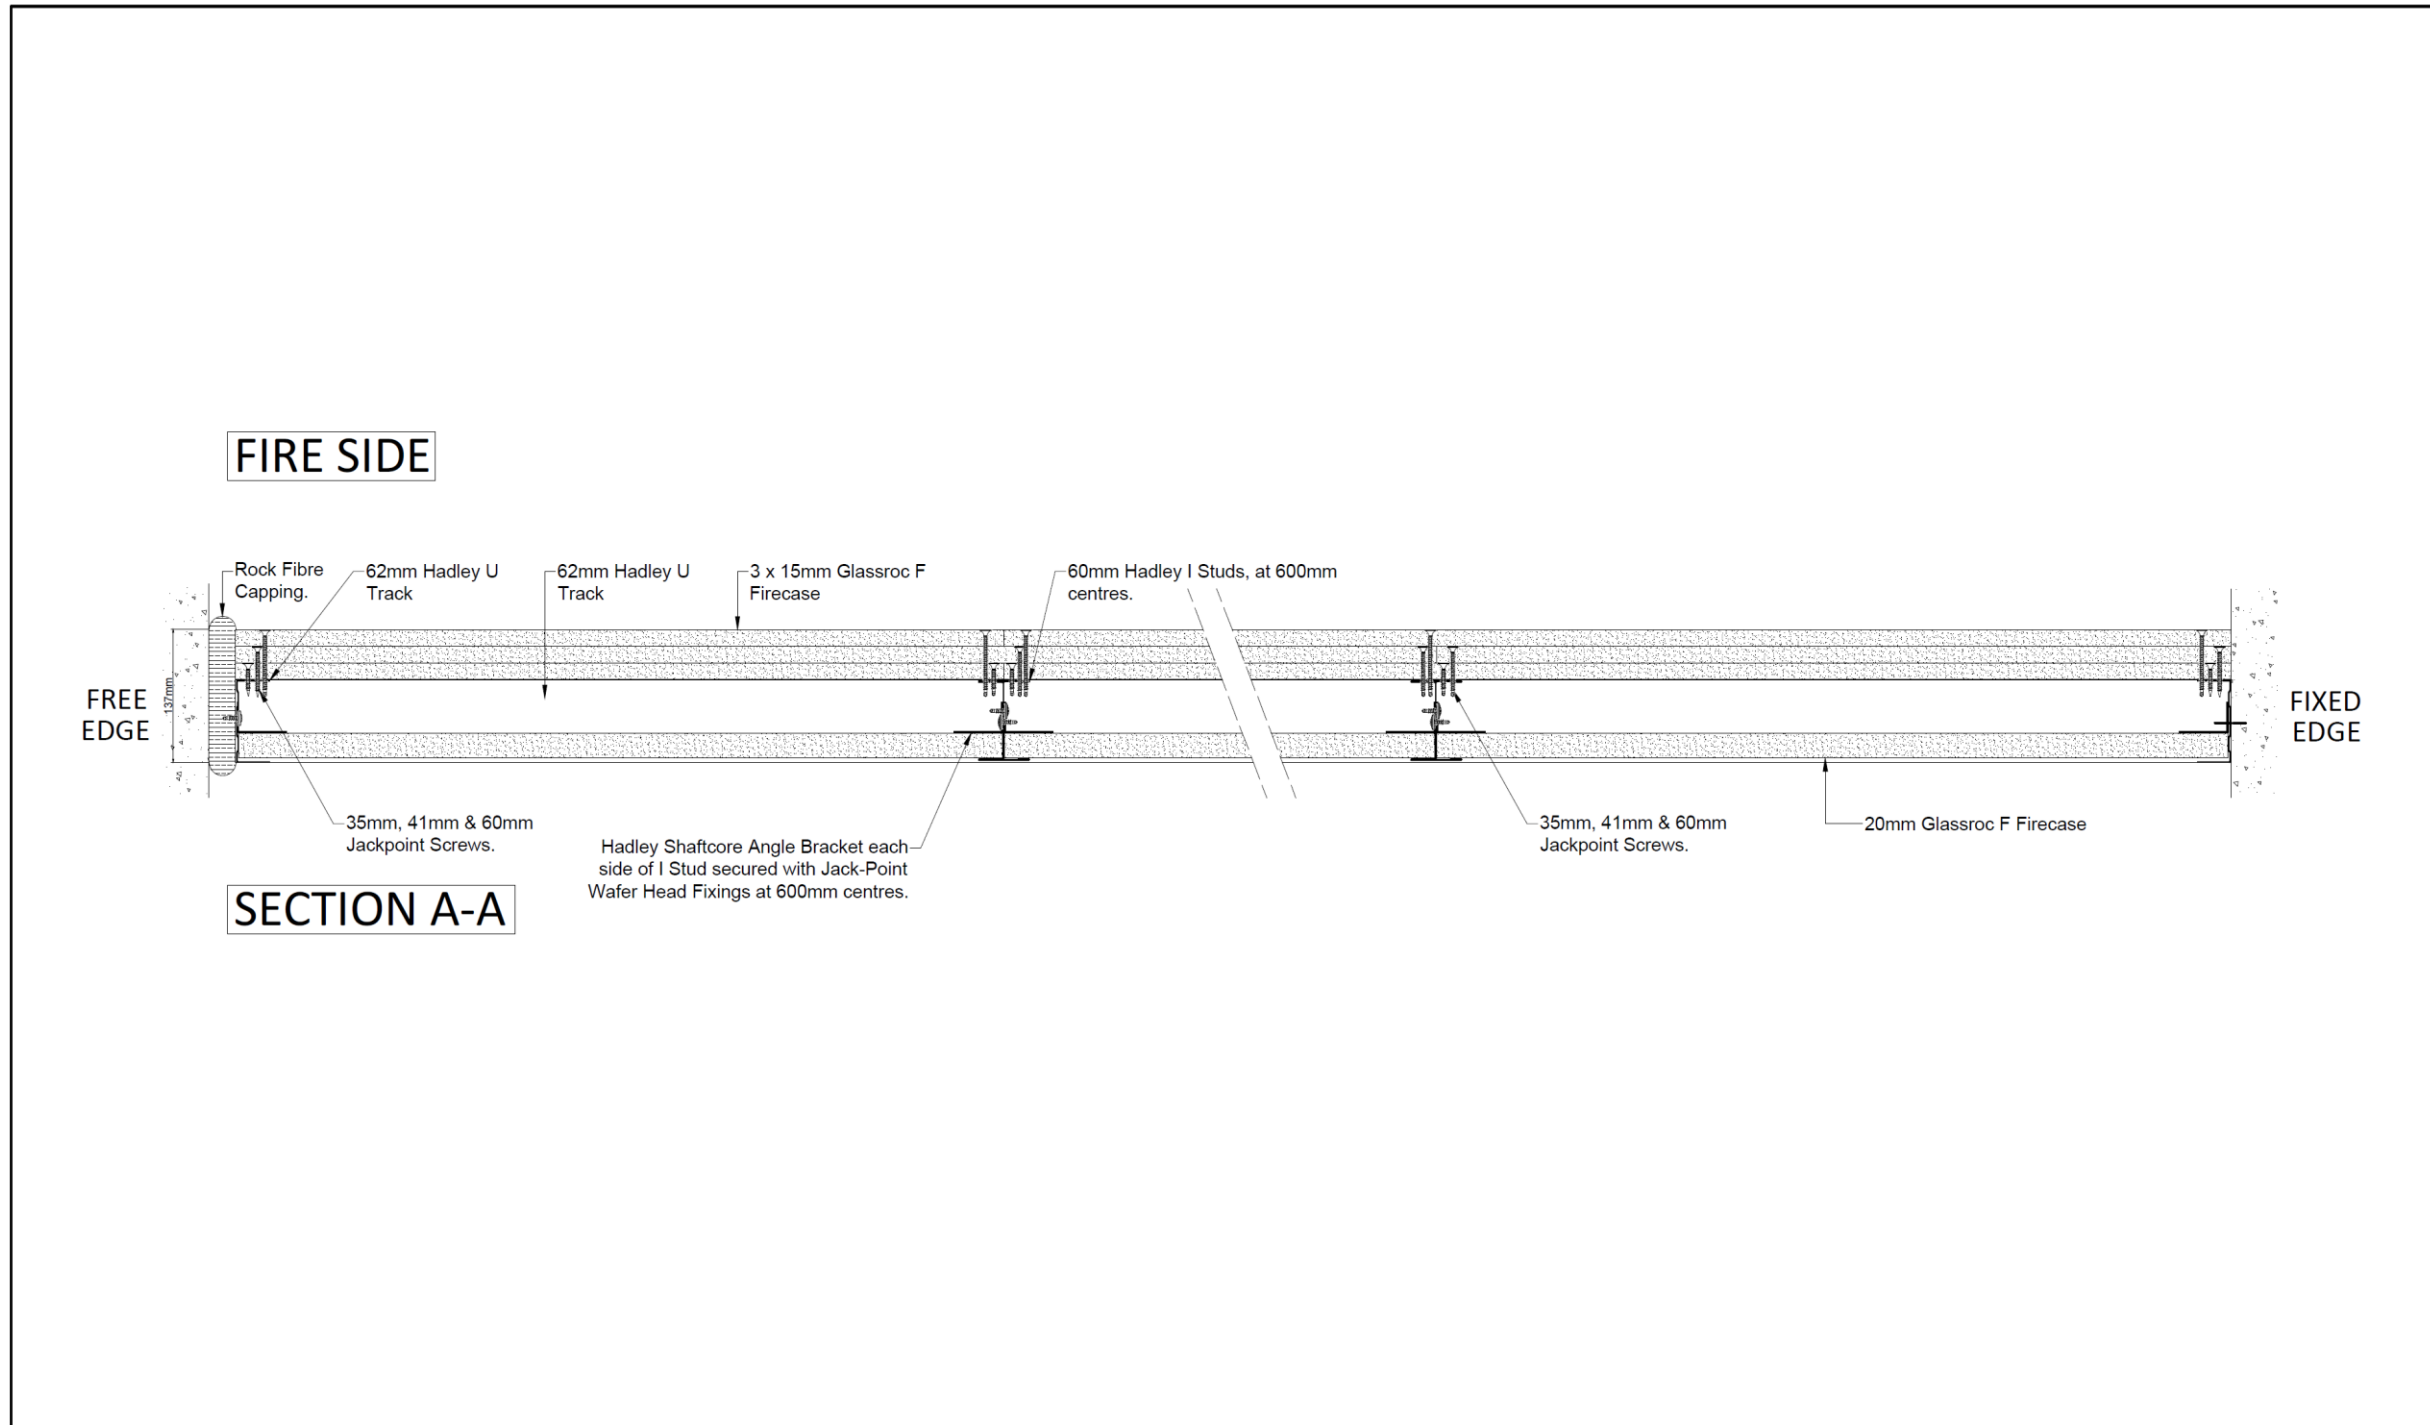
Drawing 1 – Horizontal Cross Section

TITLE: HORIZONTAL CROSS SECTIONS (SECTION A-A)	DWG_NUMBER: SHAFT-60-I-B-3X15-GFFC-GFFCE-01		HADLEY GROUP		
SYSTEM: 3 x 15mm BRITISH GYPSUM GLASSROC F FIRECASE BOARDS ONE SIDE, 20MM GLASSROC F FIRECASE OTHER SIDE WITH 60MM HADLEY I STUDS - SHAFTWALL SYSTEM	TEST_REF: EUI-23-000615		TEST_DATE: 24/10/23	PHONE: +44 (0) 121 555 1300 EMAIL: drylining.technical@hadleygroup.com	
	DATE: 20/06/2023		DRN: FM	SCALE: NTS

The sample frame consisted of six LGS studs: Two tracks reference Hadley Track (HADLEY DRYLINING), 62 x 25mm (depth x flange) at the sides and four I studs reference 60mm Hadley I Stud (HADLEY DRYLINING). These studs were placed at 600 centres and fixed on a head track reference Hadley Deep Track, 62 x 50mm (depth x flange) and base track reference, Hadley Track, 62 x 25mm (depth x flange), by one screw reference Sheet & Framing Screws, 4.2 x 19mm (Ø x L), (TIMCO) per junction. The fire side flange of the tracks at the sides were inside the base track and the non-fire side of the tracks at the sides was outside the base track. Two continuous beads of Sealant reference Gyproc Sealant (BRITISH GYPSUM) were applied under head and base tracks.

The framing system was fixed to the frame with Concrete Screws, reference Easydrive Tx Countersunk Concrete Screws (EASYFIX), with 7.5 x 50mm (Ø x L) for top and bottom frame to test rig and 7.5 x 80mm (Ø x L) for side frame to test rig, all at 600mm centres on all sides except for the free edge which was left unrestrained.

See Drawings 1, 2 and 6, Appendix A for the sample frame.

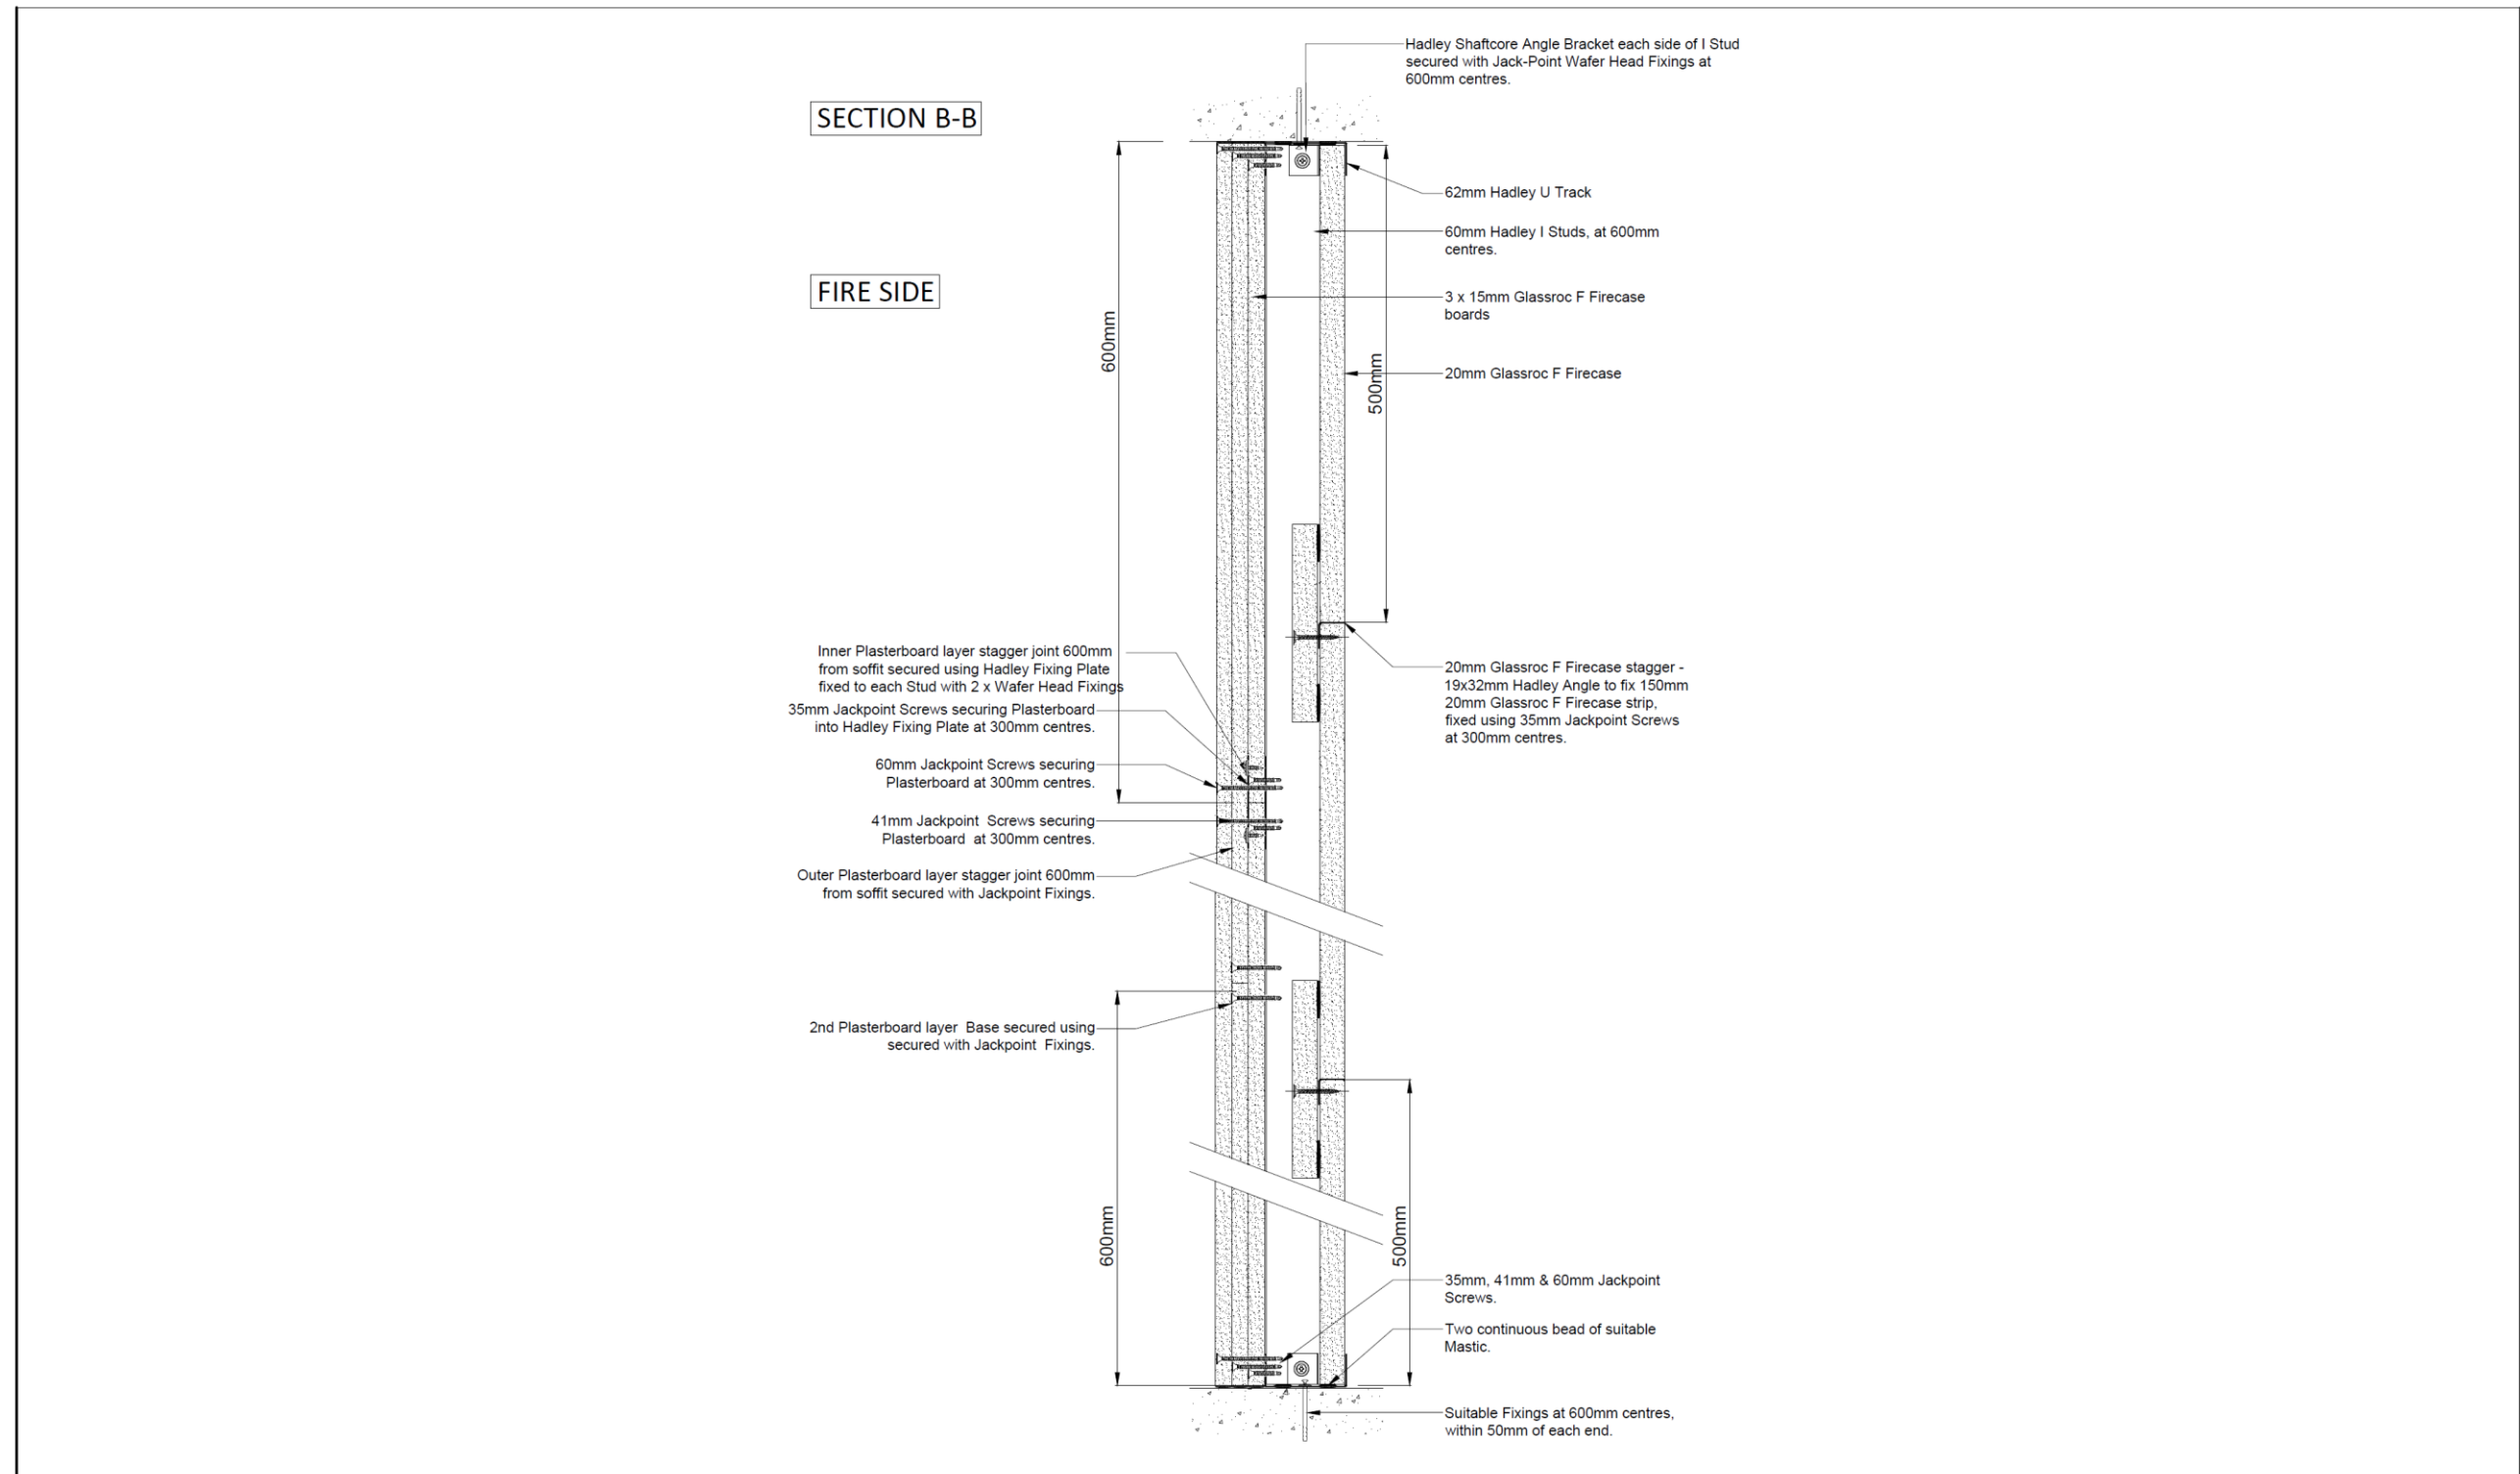
Drawing 2 – Vertical Cross Section

TITLE: VERTICAL CROSS SECTIONS (SECTION B-B)	DWG_NUMBER: SHAFT-60-I-B-3X15-GFFC-GFFCE-02

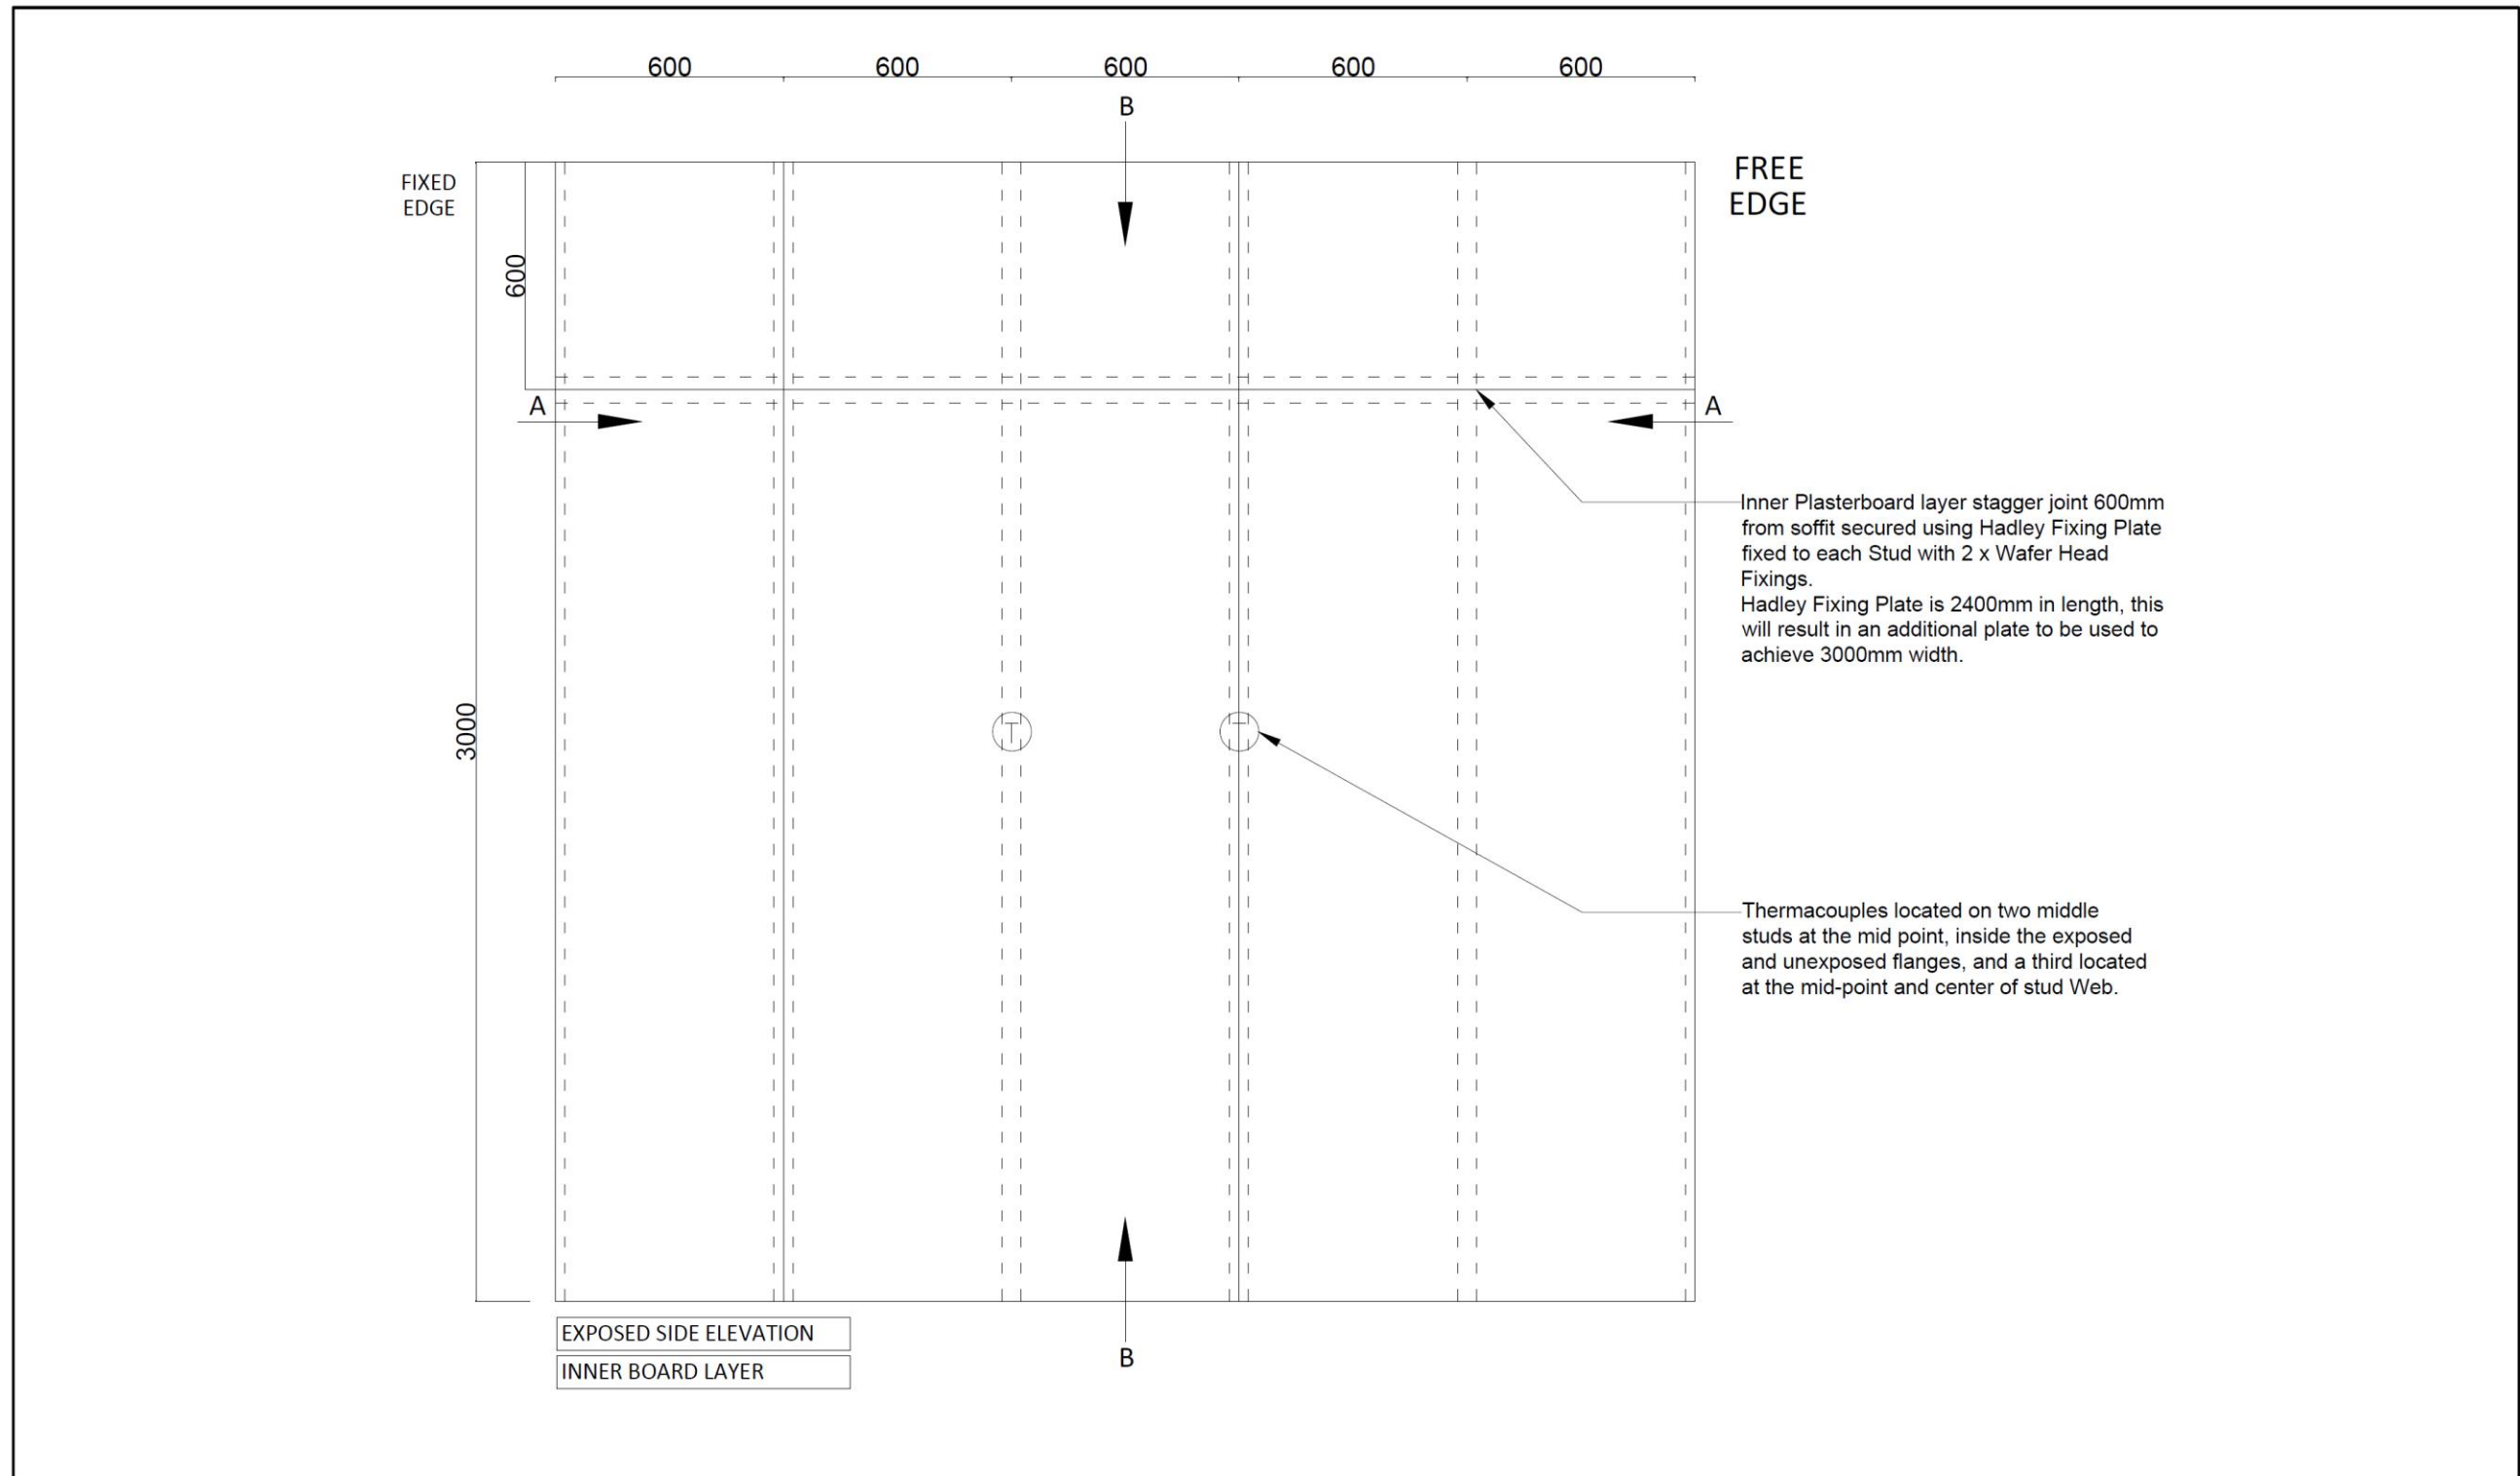
Drawing 3 – Exposed Side Elevation – Inner layer

TITLE: EXPOSED SIDE ELEVATION - INNER BOARD LAYER		DWG_NUMBER: SHAFT-60-I-B-3X15-GFFC-GFFCE-03

A flat strap (HADLEY DRYLINING), 70mm wide, on the exposed side of the frame behind the first layer of horizontal joint was fixed by 2No screws, reference Sheet & Framing Screws, 4.2 x 19mm (Ø x L), (TIMCO) per junction. The exposed side was boarded with triple layer of plasterboard, reference Glasroc F FireCase 15mm (BRITISH GYPSUM). Flat straps (HADLEY DRYLINING), 70mm wide, behind the horizontal joint behind the second layer of plasterboard and behind the third layer of plasterboard were placed using the plasterboard screws. The first layer of the plasterboard was fixed to the frame using screws reference Jack-Point Screws 35mm (BRITISH GYPSUM) at 300mm centres along the stud lines and in perimeter and second layer of the plasterboard was fixed to the frame using screw reference Jack-Point Screws 41mm (BRITISH GYPSUM) at 300mm centres along the stud lines and in perimeter and third layer of the plasterboard was fixed to the frame using screw reference Jack-Point Screws 60mm (BRITISH GYPSUM) at 300mm centres along the stud lines and in perimeter.

See Drawing 3, 4 and 5, Appendix A for the boarding layouts.

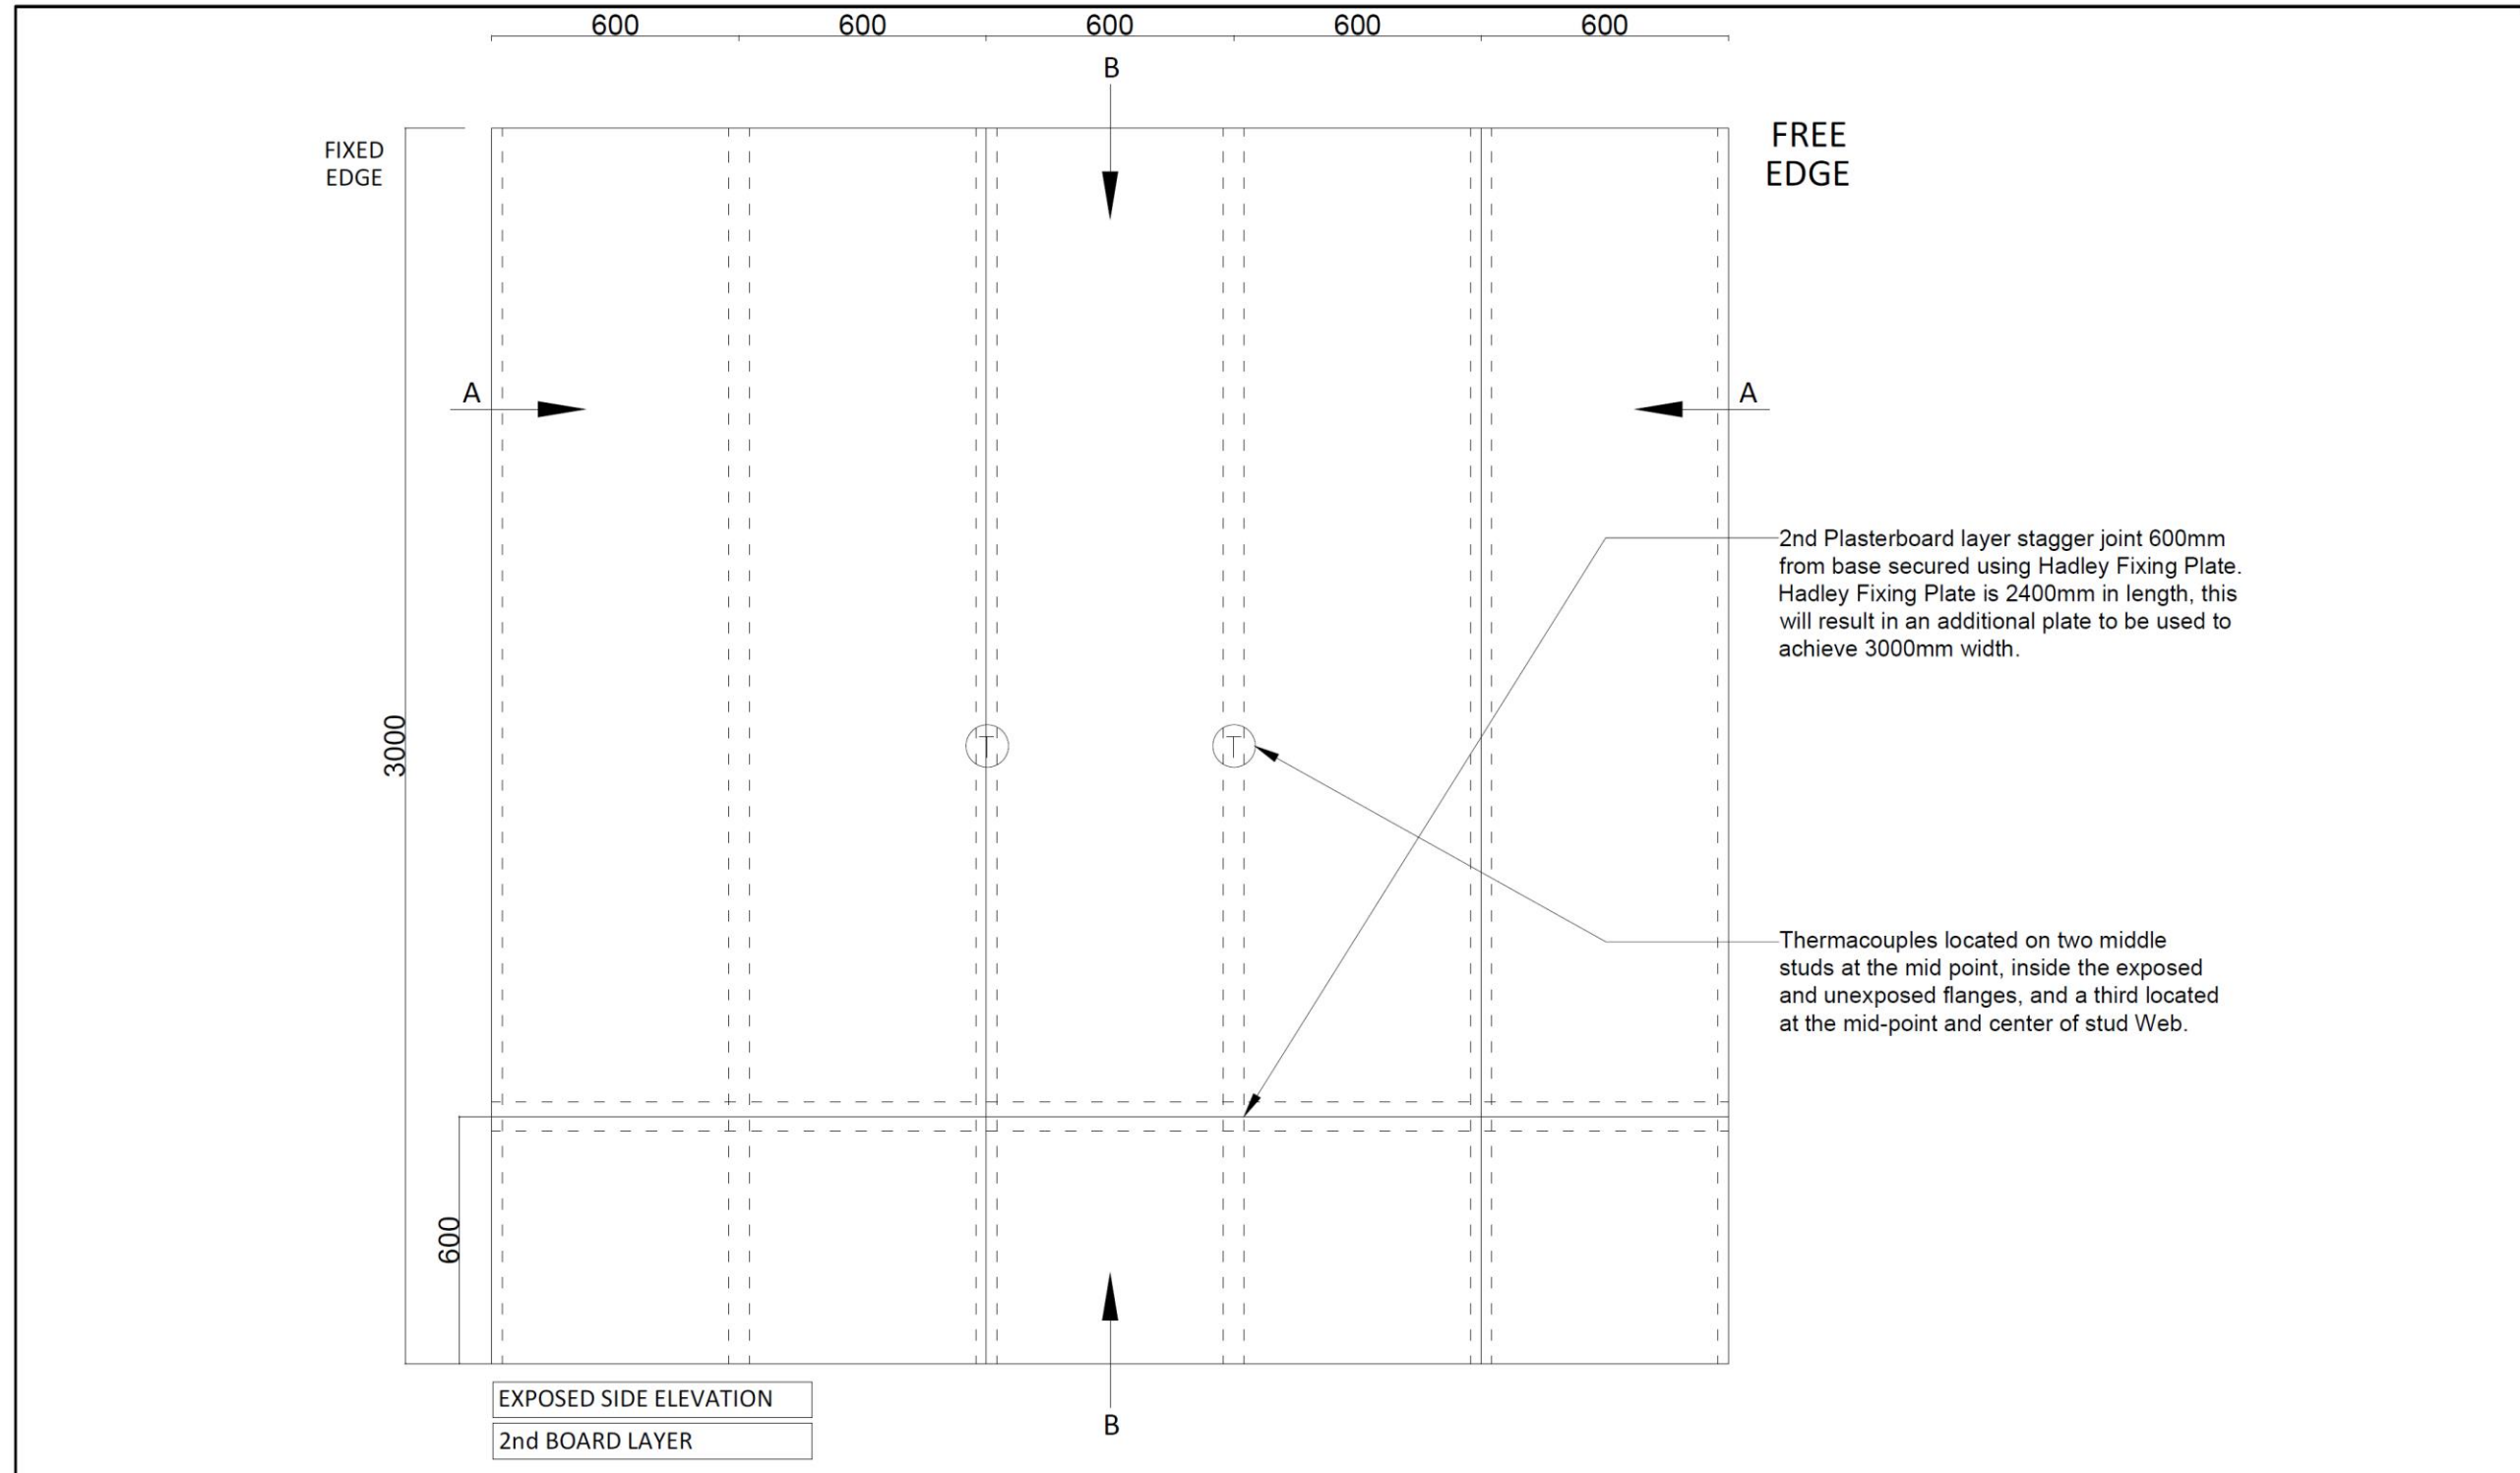
Drawing 4 – Exposed Side Elevation – 2nd layer

TITLE: EXPOSED SIDE ELEVATION - 2ND BOARD LAYER	DWG_NUMBER: SHAFT-60-I-B-3X15-GFFC-GFFCE-04

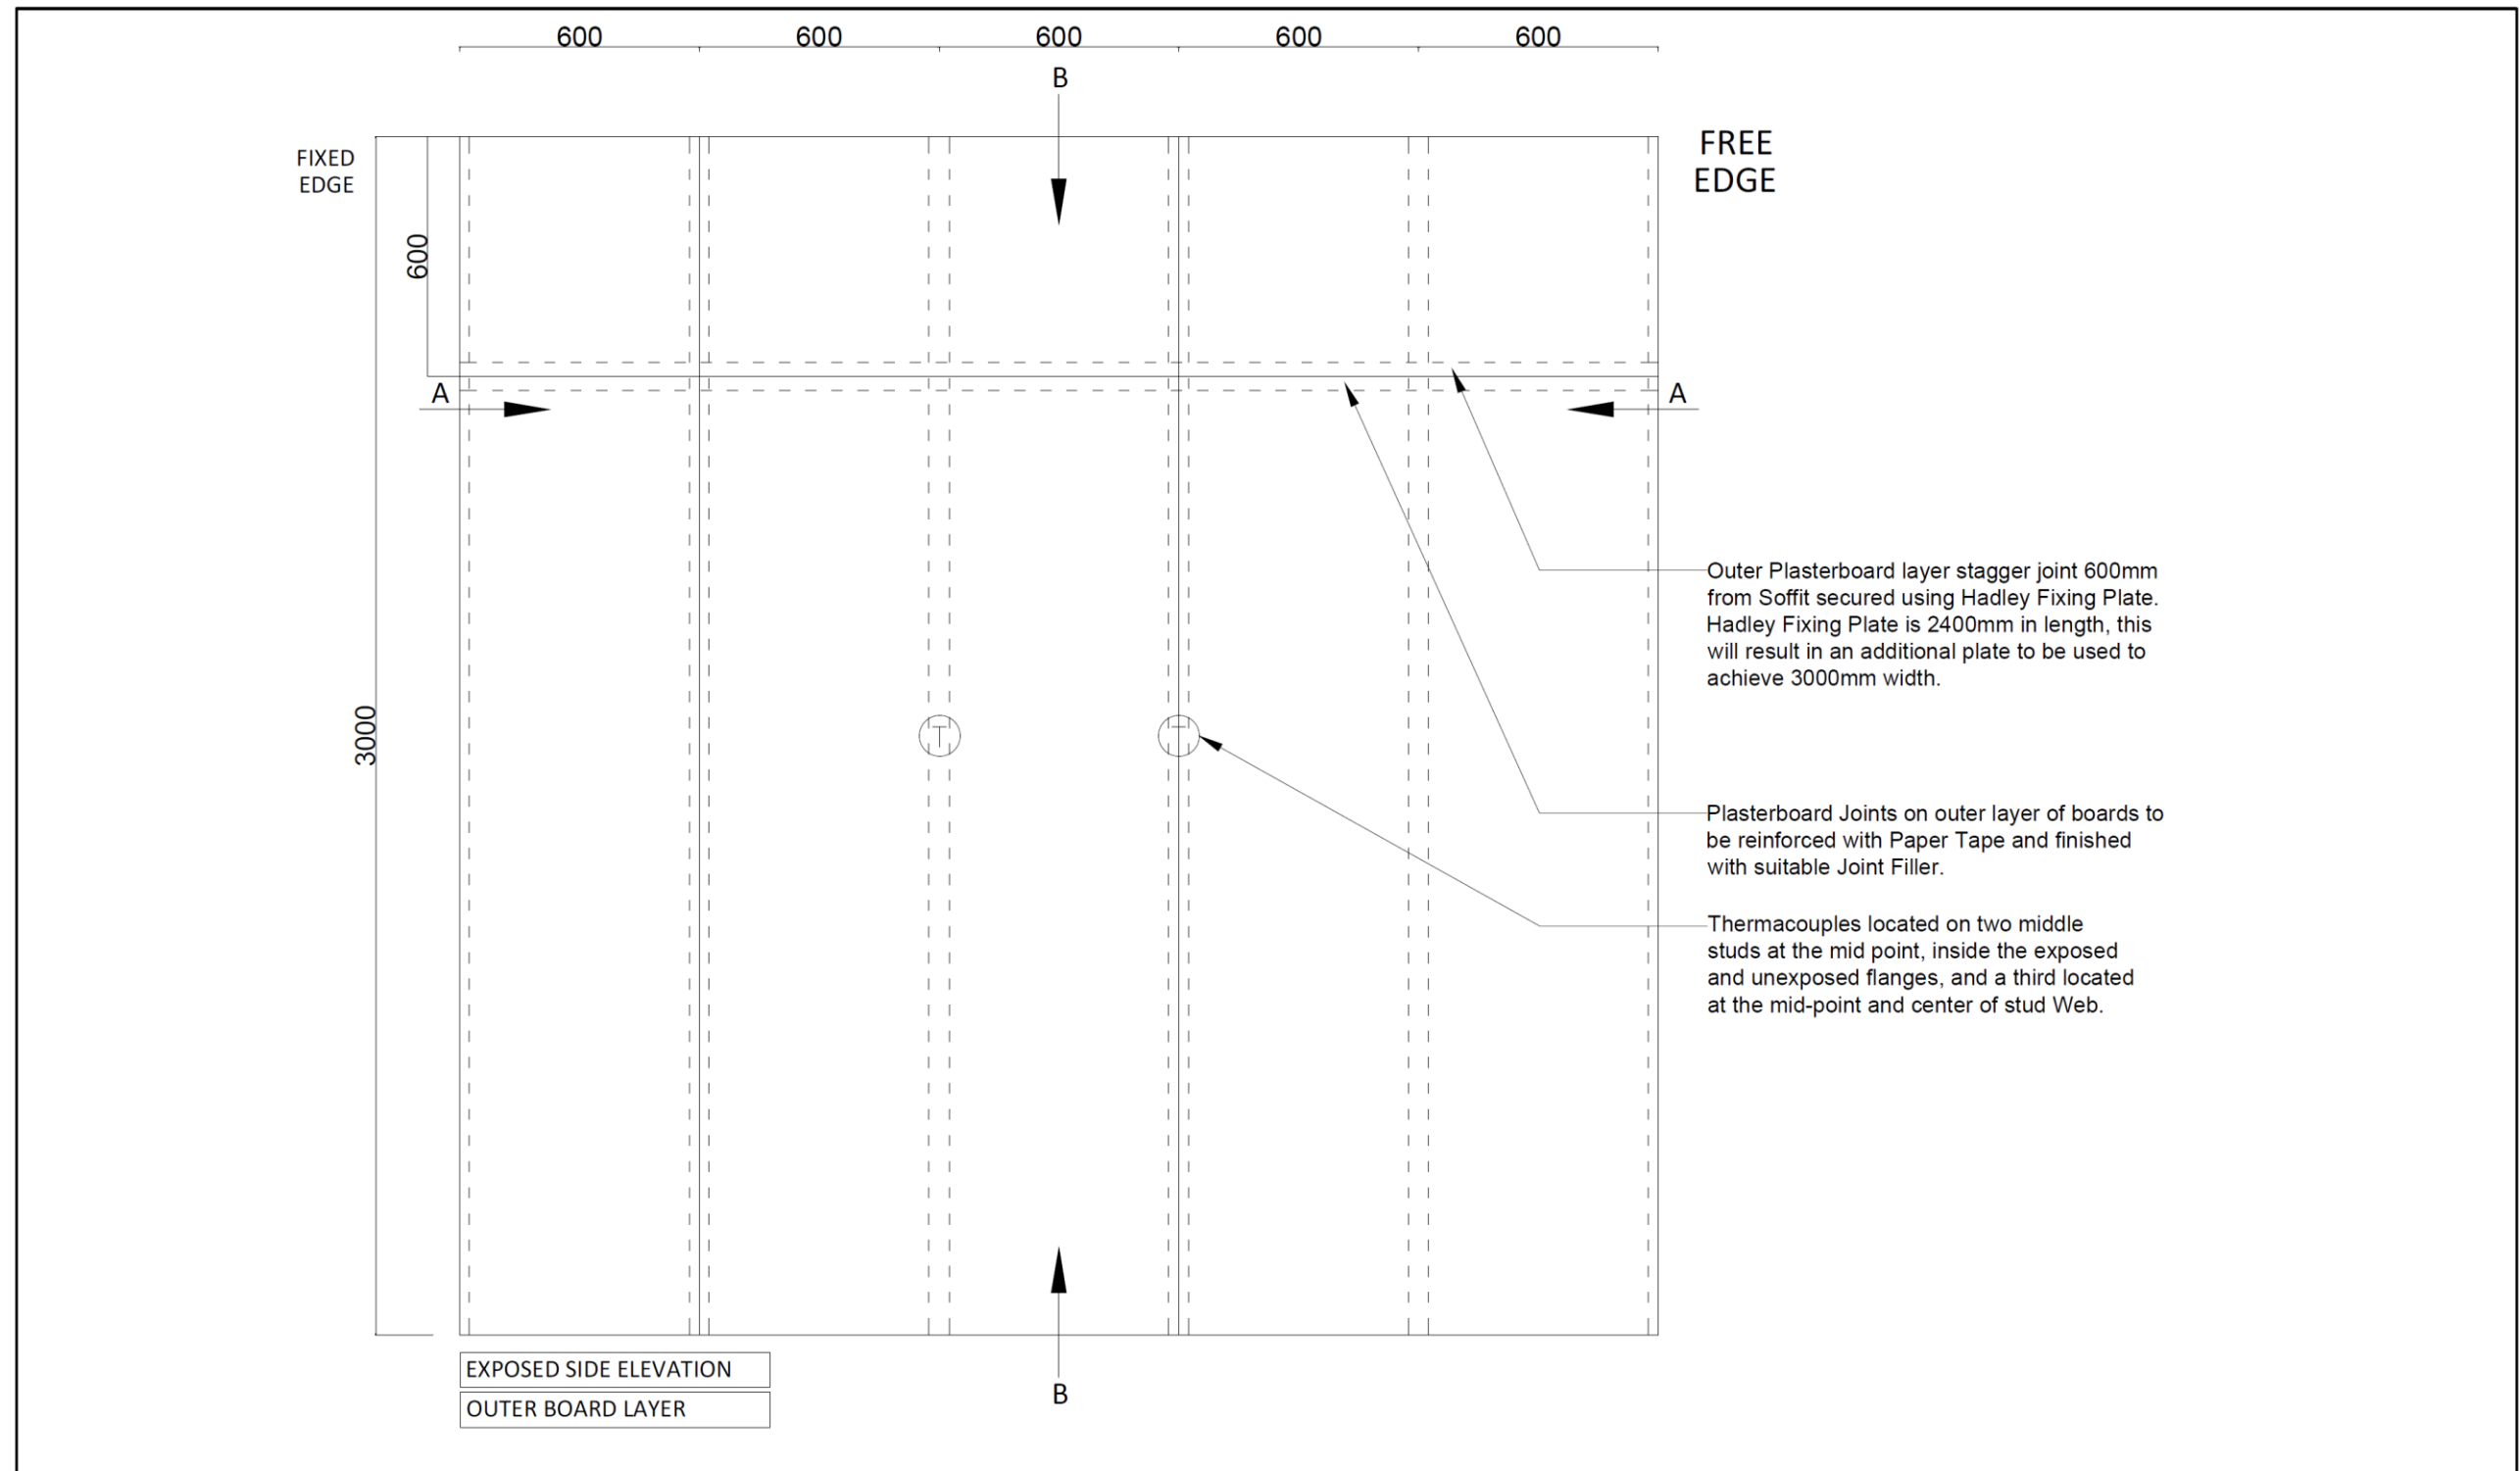
Drawing 5 – Exposed Side Elevation – Outer layer

TITLE: EXPOSED SIDE ELEVATION - OUTER BOARD LAYER	DWG_NUMBER: SHAFT-60-I-B-3X15-GFFC-GFFCE-05
