FIRE TEST REPORT EUI-23-B-000615

According to BS EN 1363-1:2020 and BS EN 1364-1:2016 +A1:2018

Test	EUI-23-B-000615
Performed on	24th October 2023
Regarding	SHAFT-60-I-B-3X15-GFFC-GFFCE One Non-loadbearing wall Unexposed side: One layer of plasterboard reference Glasroc F FireCase 20mm, (BRITISH GYPSUM) Exposed side: Triple layer of plasterboard reference Glasroc F FireCase 15mm, (BRITISH GYPSUM)
Sponsor	Hadley Group Technology (A division of Hadley Sections Ltd) Ltd. P.O Box 92 Downing Street B66 2PA Smethwick, West Midlands UNITED KINGDOM

Reference: SHAFT-60-I-B-3X15-GFFC-GFFCE

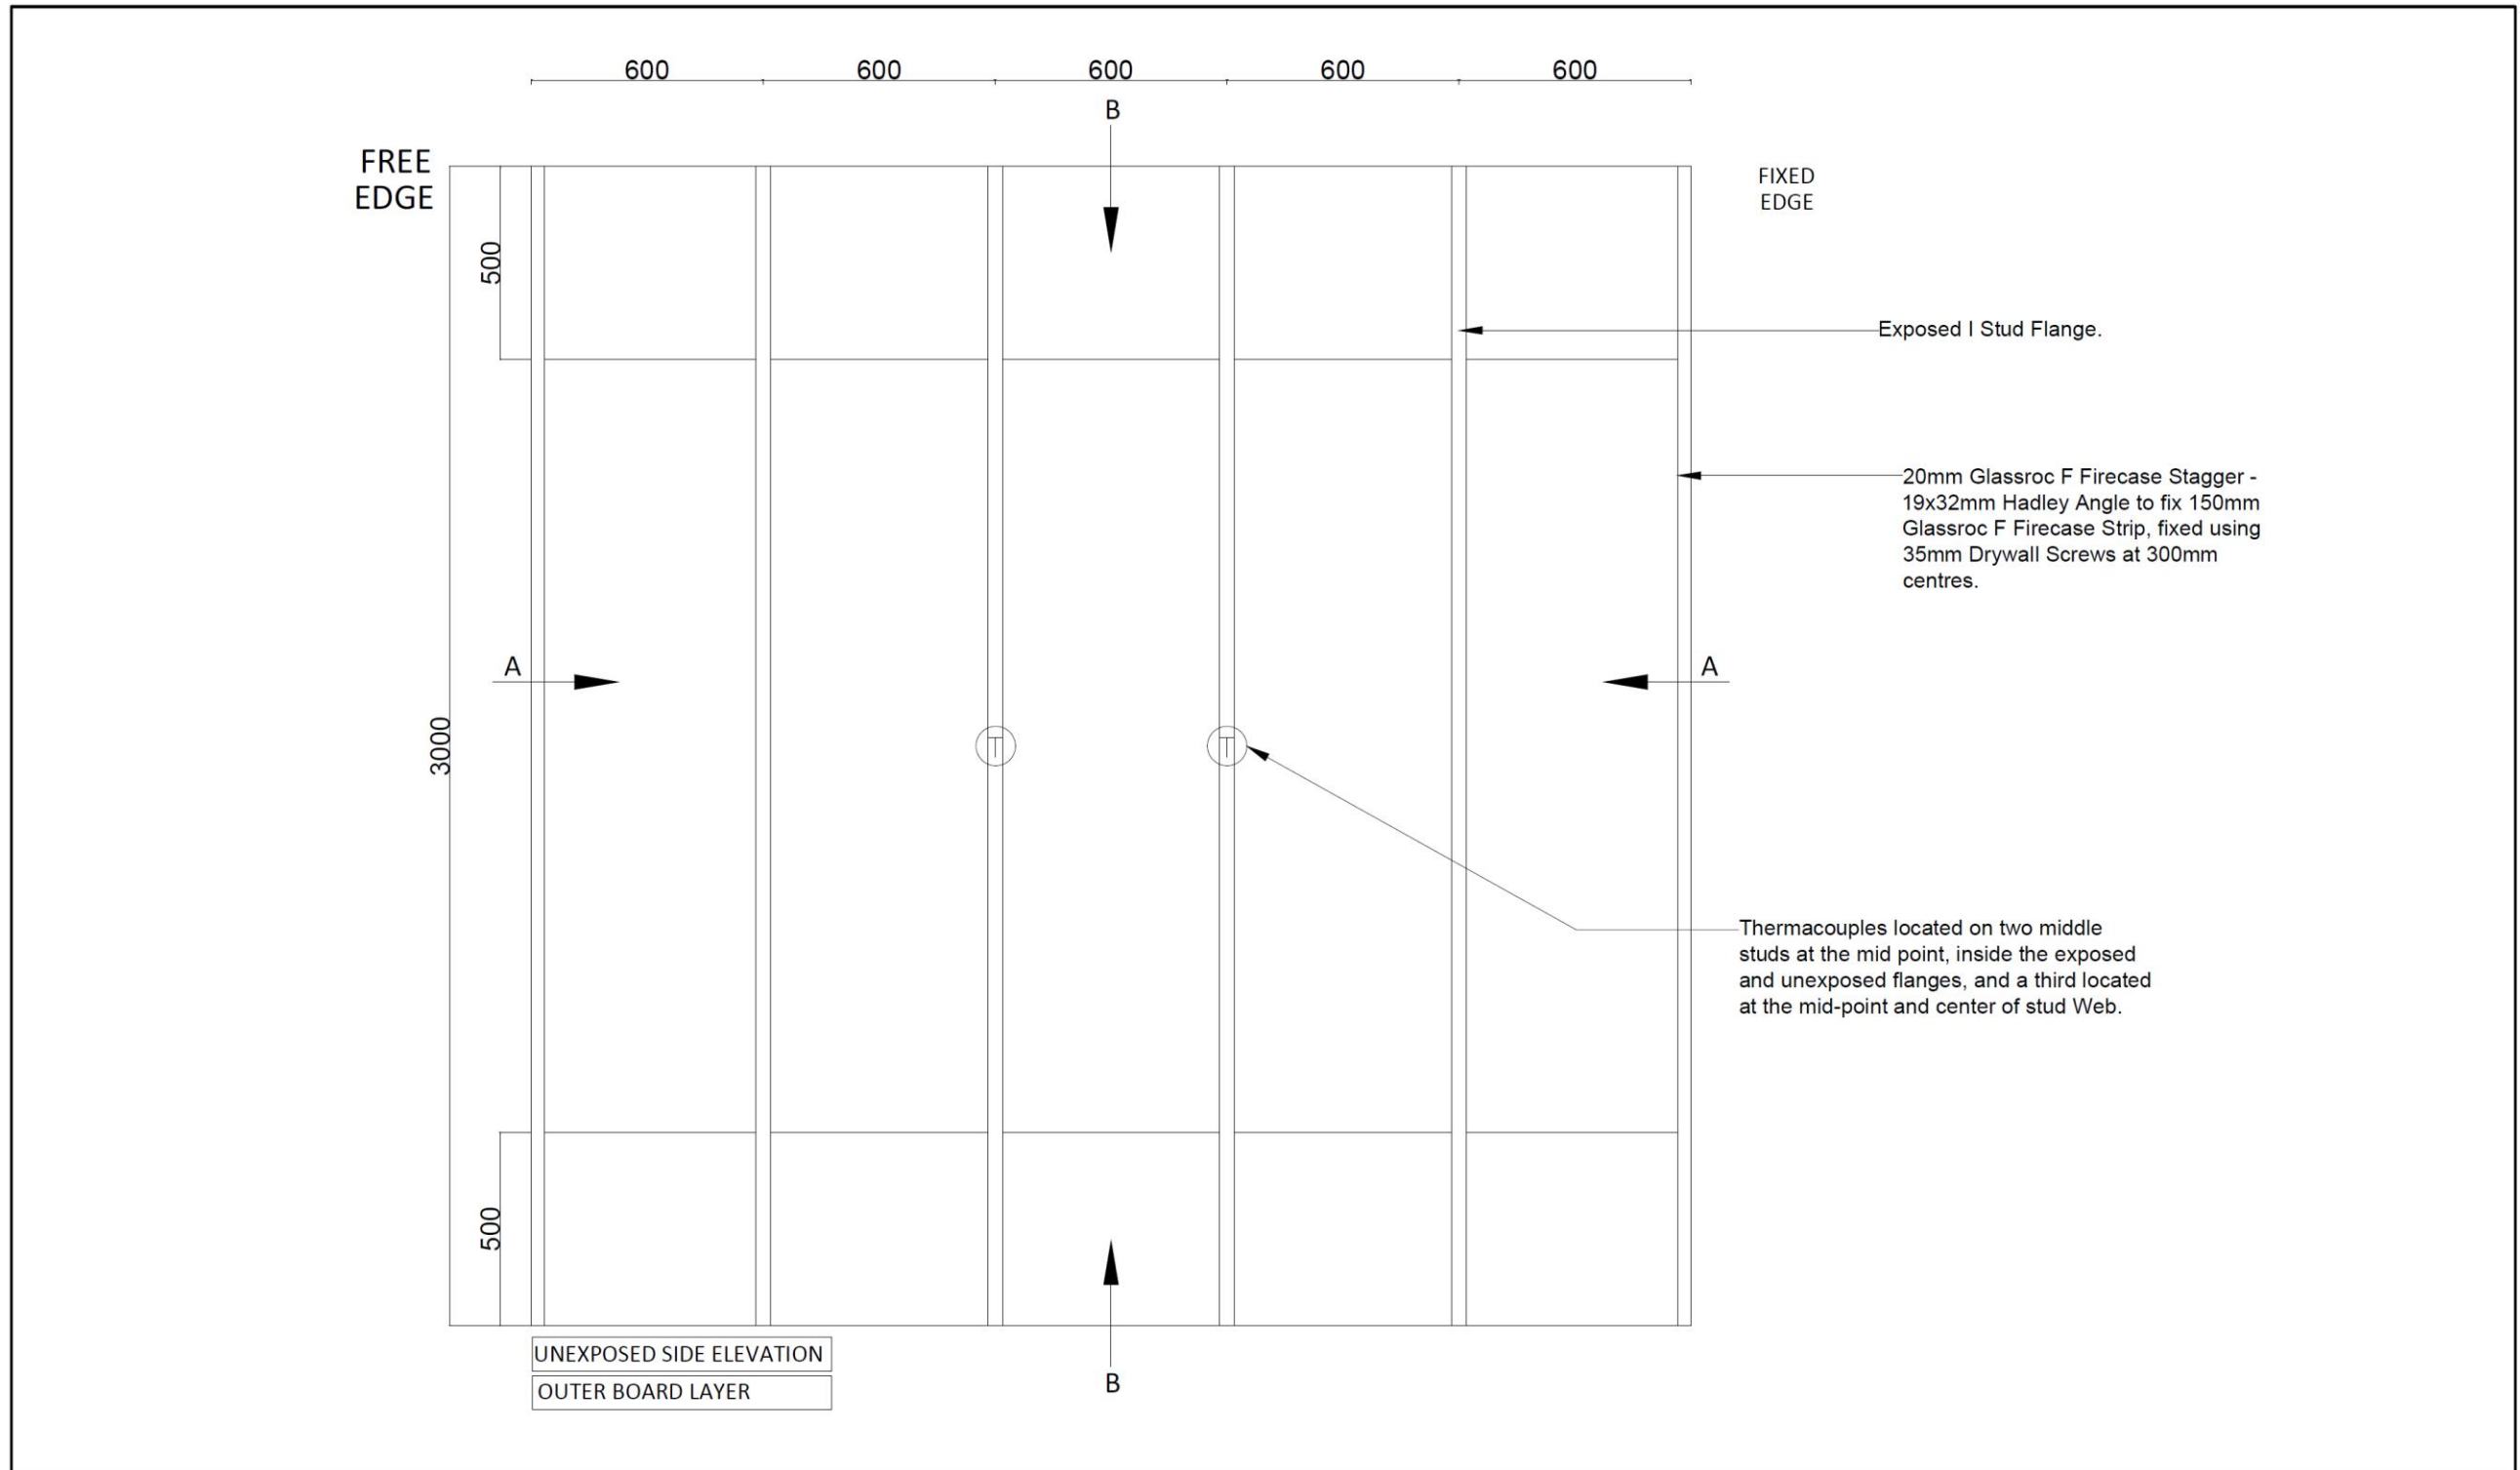
Drawing 6 – Unexposed Side Elevation

TITLE: UNEXPOSED SIDE ELEVATION - OUTER BOARD LAYER	DWG_NUMBER: SHAFT-60-I-B-3X15-GFFC-GFFCE-06

See Drawings 1, 2 and 6, Appendix A for the sample frame.

The unexposed side was boarded with one layer of plasterboard, reference Glasroc F FireCase 20mm (BRITISH GYPSUM). The boards were fixed with brackets reference Shaftcore Angle Bracket (HADLEY DRYLINING) with 2No screws reference Sheet & Framing Screws, 4.2 x 19mm (Ø x L), (TIMCO) per junction on the web of the studs at 600m centres. A steel 'L' angle, reference Gypframe GA3 Steel Angle (BRITISH GYPSUM), 19mm depth x 32mm length, was put between the horizontal joints with sealant, reference Gyproc Sealant (BRITISH GYPSUM), on the top of the angle. From the fire side, horizontal joints were covered with 150mm height plasterboard, reference Glasroc F FireCase 20mm (BRITISH GYPSUM) with sealant, reference Gyproc Sealant (BRITISH GYPSUM), applied on the top and bottom board of the board and screwed with Jack-Point Screws 35mm (BRITISH GYPSUM) one on the right and one on the left side of the board.

See Drawing 6, Appendix A for the boarding layout.

Location	Markings	Appendix
On the centre of each quarter section	1, 2, 4, 5	B
On the geometric centre of the specimen	3	
At the top of the specimen adjacent to joint	6, 8, 11, 13	
At the top of the specimen in line with a stud	7, 9, 12, 14	
At the top of the specimen, at mid-width	10	
At mid width, adjacent to a horizontal joint	16, 27	
In the intersection between a horizontal joint and vertical joint	15, 17, 26, 28	
At mid-height, 150 mm in from the free vertical edge	18	
At mid-height, adjacent to a vertical joint	19, 21, 23, 24	
At mid-height, in line with a stud	20, 22	
At mid-height, adjacent to the fixed vertical edge	25	
Internal Thermocouple	Markings	Appendix
On the inside of the exposed flange on stud 3, as viewed from the unexposed side on Drawing 6	3	A
On the web of the flange on stud 3, as viewed from the unexposed side on Drawing 6	2	
On the inside of the unexposed flange on stud 3, as viewed from the unexposed side on Drawing 6	1

On the inside of the exposed flange on stud 4, as viewed from the unexposed side on Drawing 6	6	
On the web of the flange on stud 4, as viewed from the unexposed side on Drawing 6	5	
On the inside of the unexposed flange on stud 4, as viewed from the unexposed side on Drawing 6	4

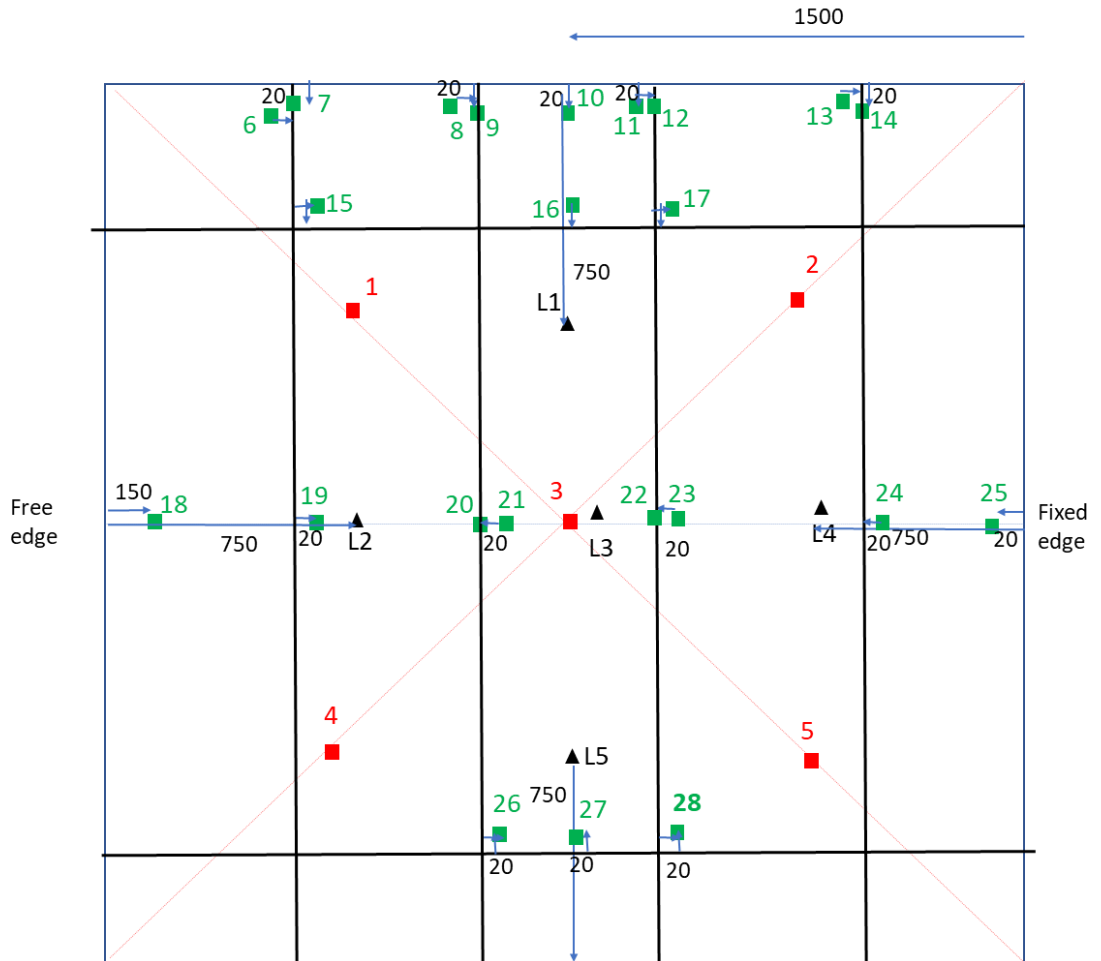
Figure 1 - Plot of the external instrumentation (as viewed from the unexposed side)

- Thermocouples for average/maximum temperature rise (at least 50 mm from hotspots)
- Thermocouples for maximum temperature rise (at least 20 mm from hotspots)
- ▲ LVDTs for horizontal deflection

The temperatures were measured by 28 external thermocouples according to the requirements of the standard BS EN 1363-1:2020 and located according to the standard BS EN 1364-1:2015, and by 6 internal thermocouples, as requested by the test Sponsor for additional data gathering.

See Figures 1, Appendix B for the plot of the instrumentation, and Charts 5 to 6, Appendix C for the measurements recorded during the test.

The deflection was measured using calibrated wire type displacement gauges and recorded via a data acquisition system. The horizontal deflection was measured at the geometric centre of the sample and at mid-height at ¼ width, from the left and right sides, and at mid-width at ¼ height from the top and bottom.

<i>Location</i>	<i>Markings</i>	<i>Appendix</i>
Mid-width, at ¾ height	1	B
Mid-height, at 750mm from edges	2 (left), 4 (right)	
Centre of the sample	3	
Mid-width, at ¼ height	5

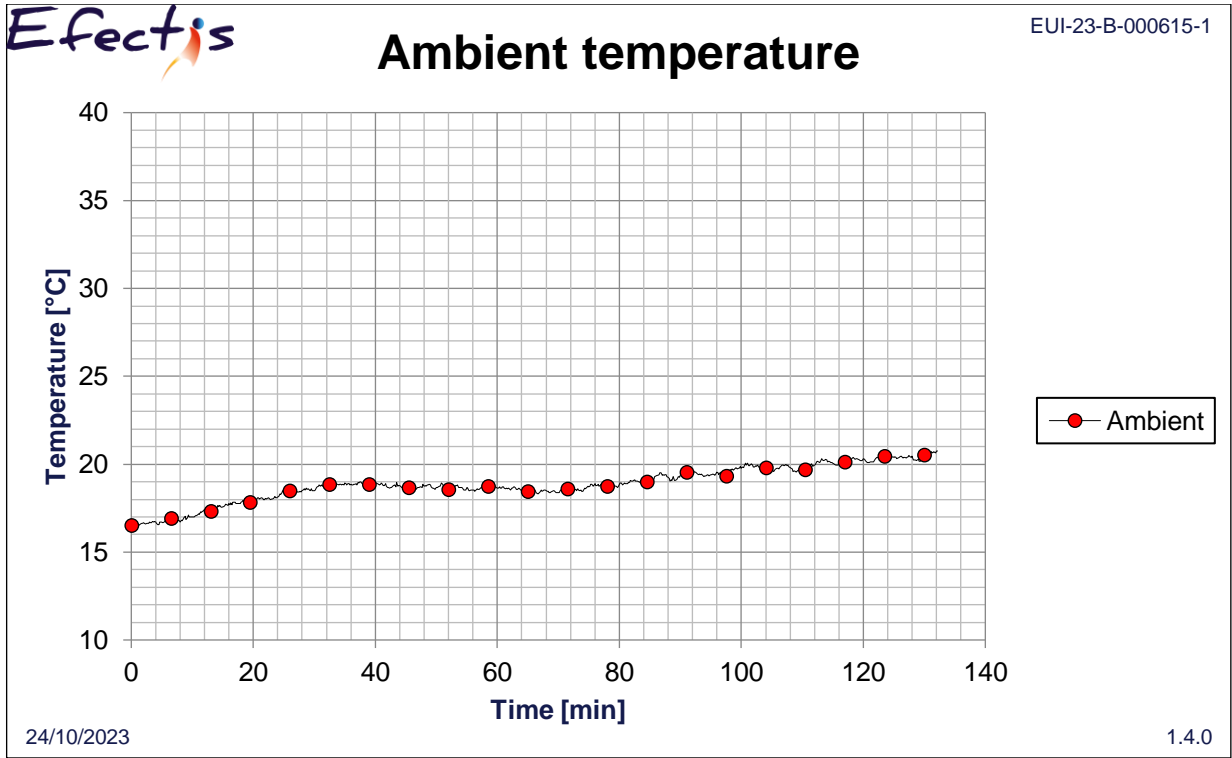
Chart 1 - Ambient laboratory temperature during the test

The ambient temperature was measured according to the requirements of the standard BS EN 1363-1:2020. See Chart 1, Appendix C for the measurements recorded during the test.

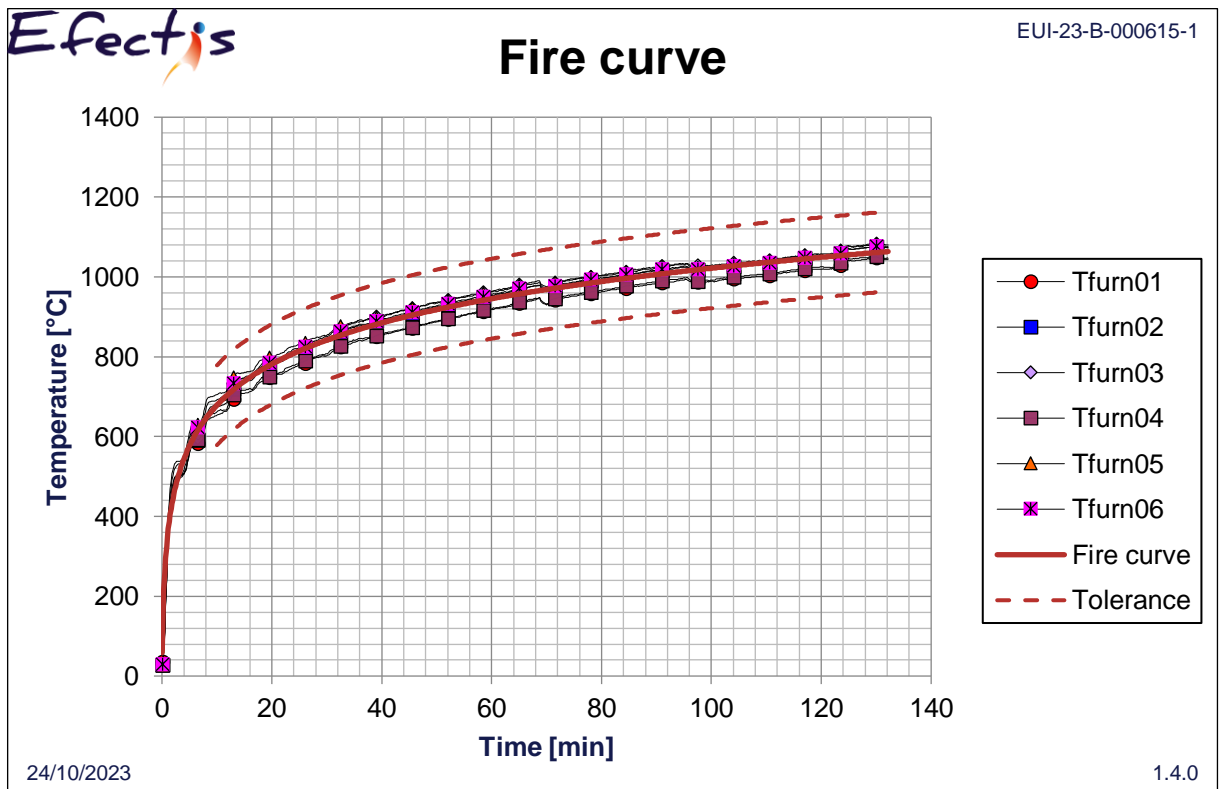
Chart 2 - Furnace temperature during the test

It was measured in conformity with the standard BS EN 1363-1:2020 by 6 plate thermocouples in the furnace, with the metal plate facing towards the back of the furnace. See Chart 2, Appendix C for the measurements recorded during the test.

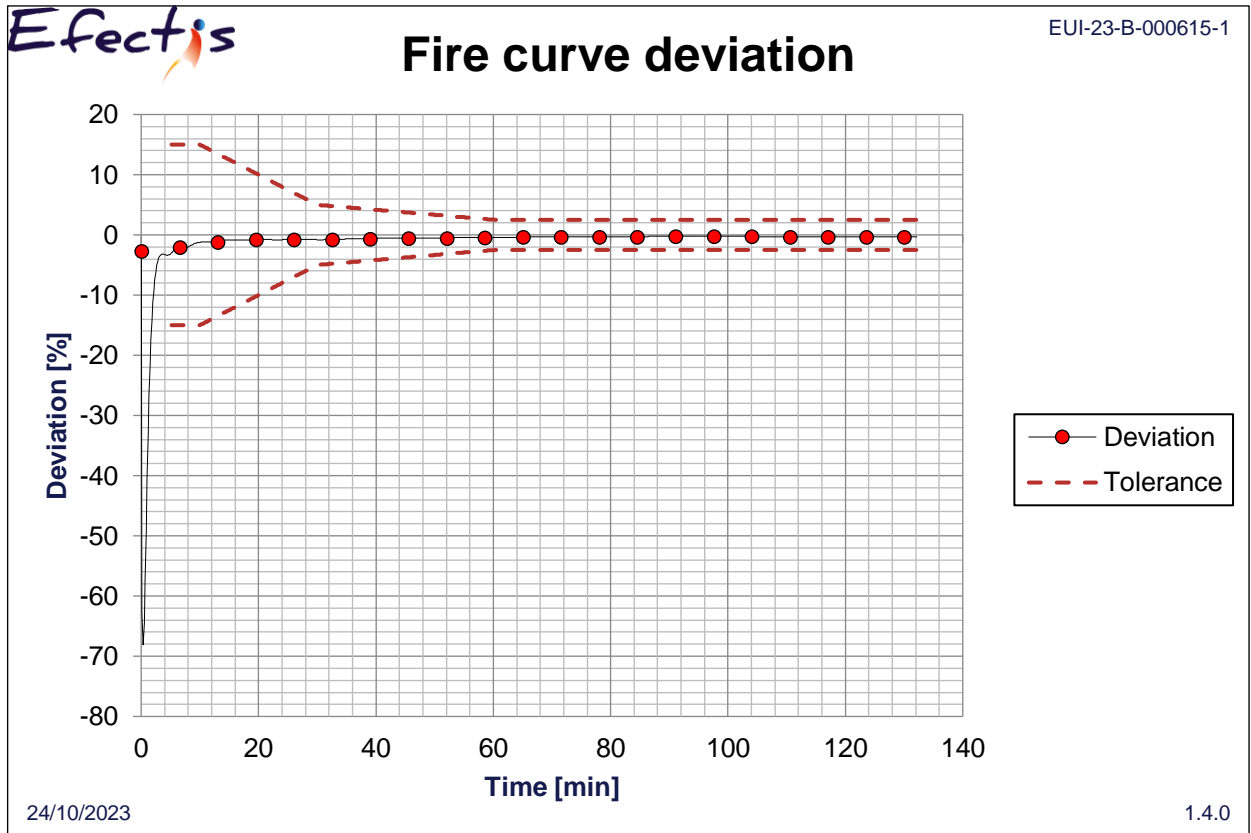
Chart 3 - Deviation curve of fire during test

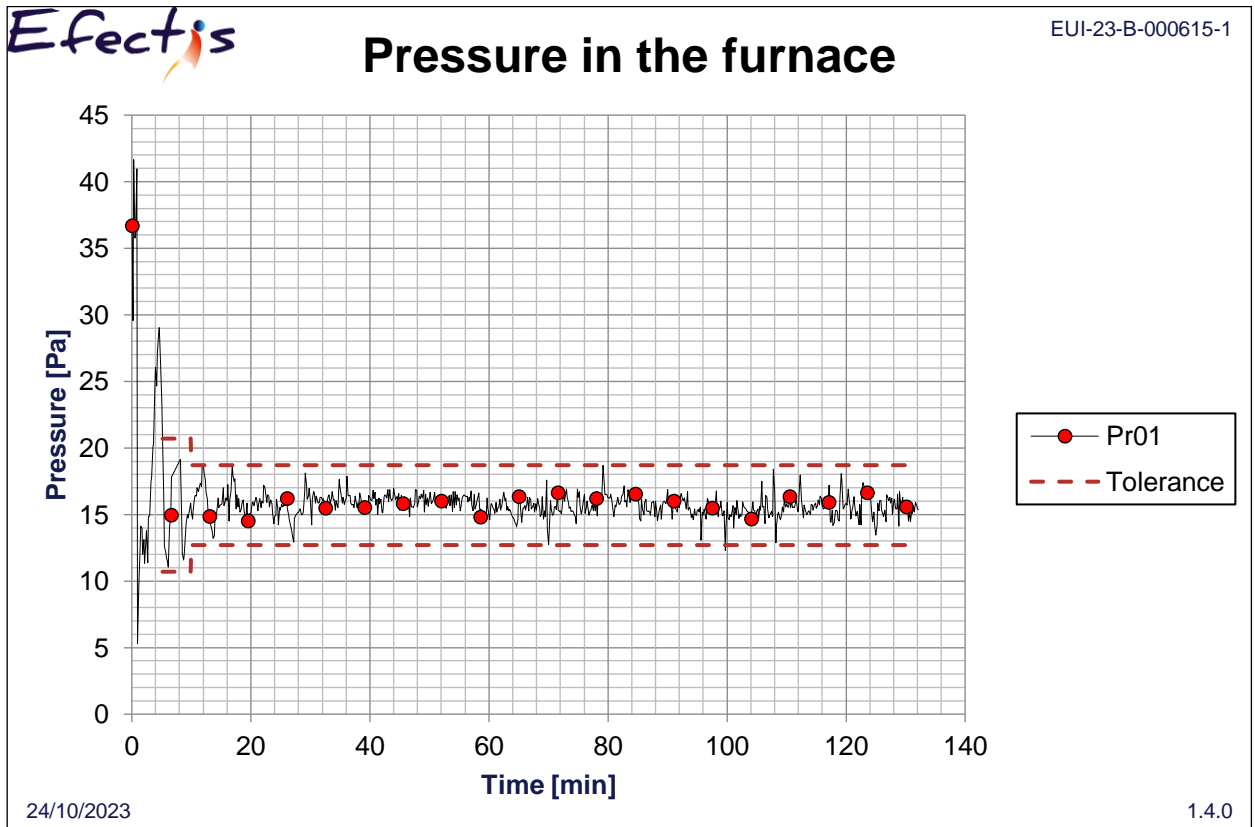
Chart 4 - Furnace pressure during the test

Taking into account the dimensions of the specimen and the location of the pressure sensor, the prescribed value was established at 15.7 Pa, equating to a pressure of 20 Pa at the head of the sample.

See Chart 4, Appendix C for the measurements recorded during the test.

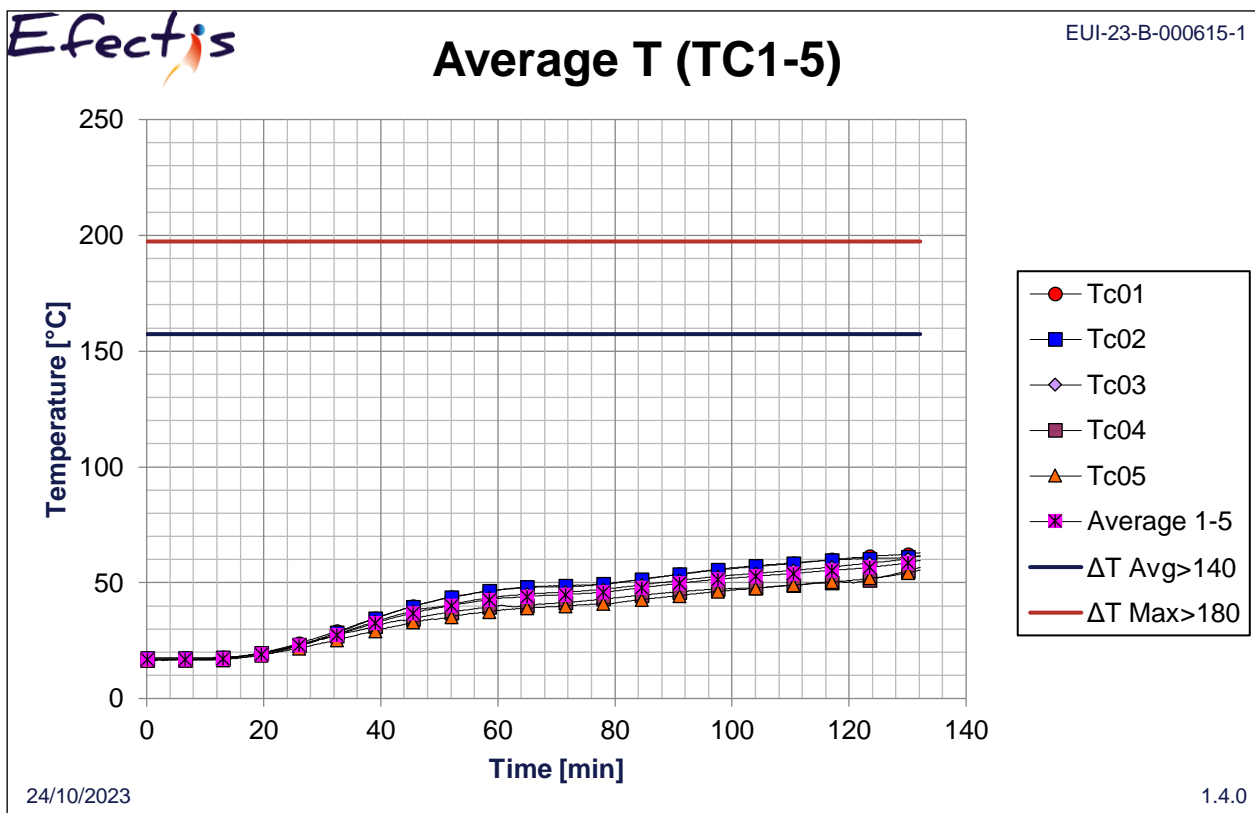
Chart 5 - Average temperature of unexposed side during the test

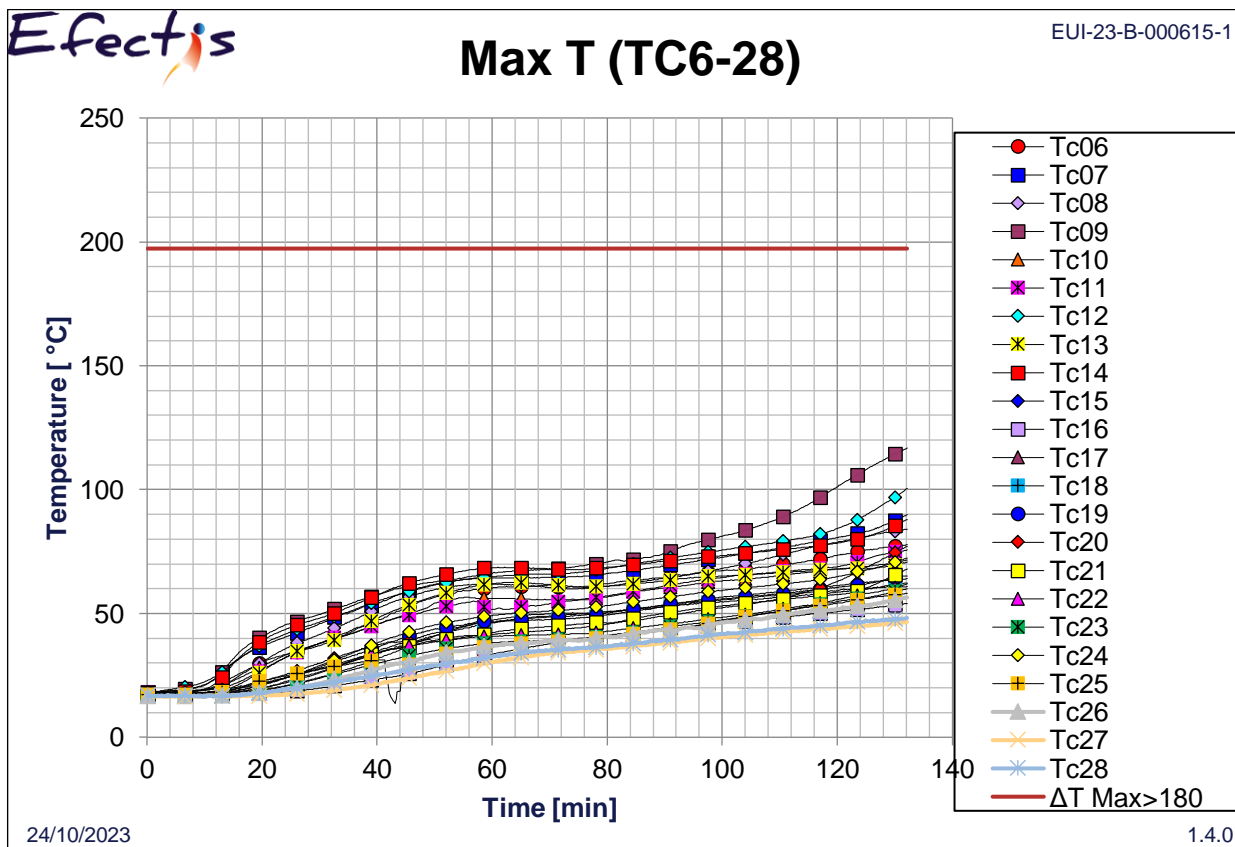
Chart 6 - Maximum temperature during the test

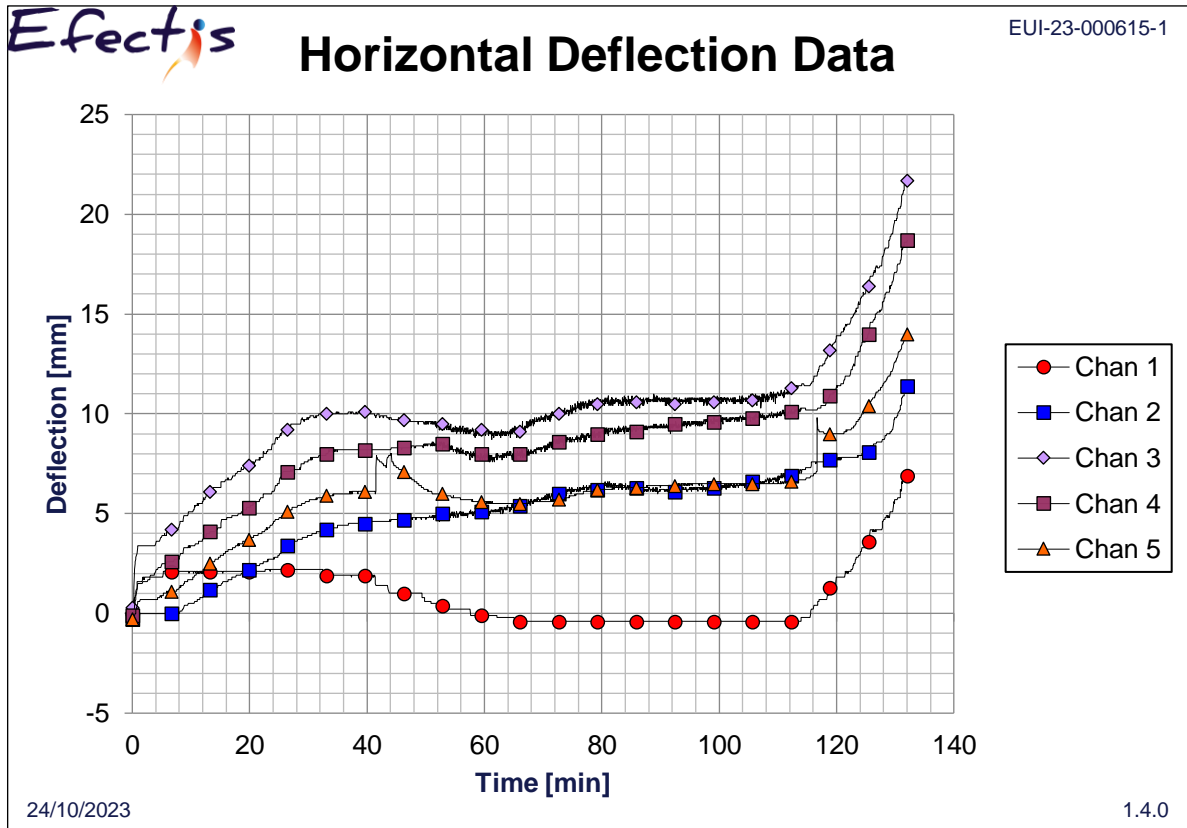
Chart 7 - Horizontal deflection during the test

See Appendix B: Instrumentation for the plot of the instrumentation and Chart 7, Appendix C for the measurements recorded during the test.

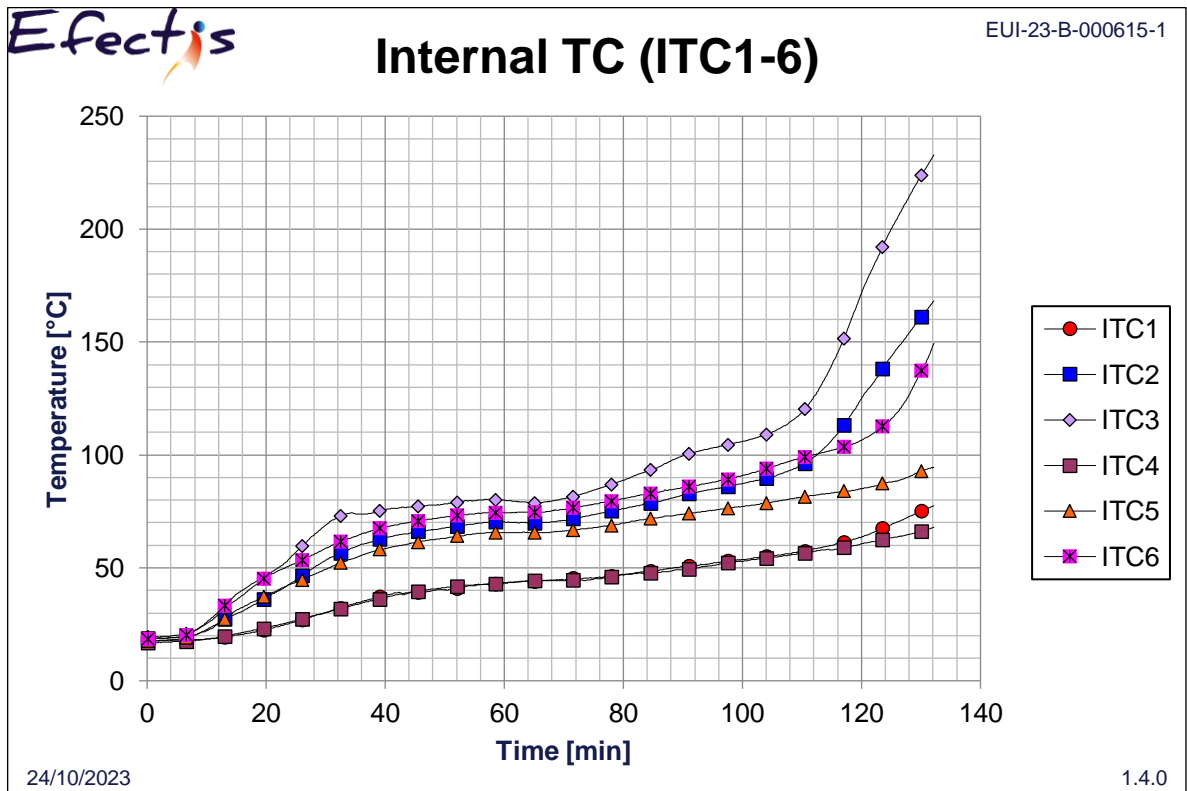
Chart 8 - Plot of internal thermocouples

The internal thermocouples were installed in central studs, at mid-height of the sample. Both studs have three thermocouples; one on the exposed flange, one on the web and one on the unexposed flange. See Drawing 6 Appendix A for the plot of the instrumentation, and Charts 8, Appendix C for the measurements recorded during the test.

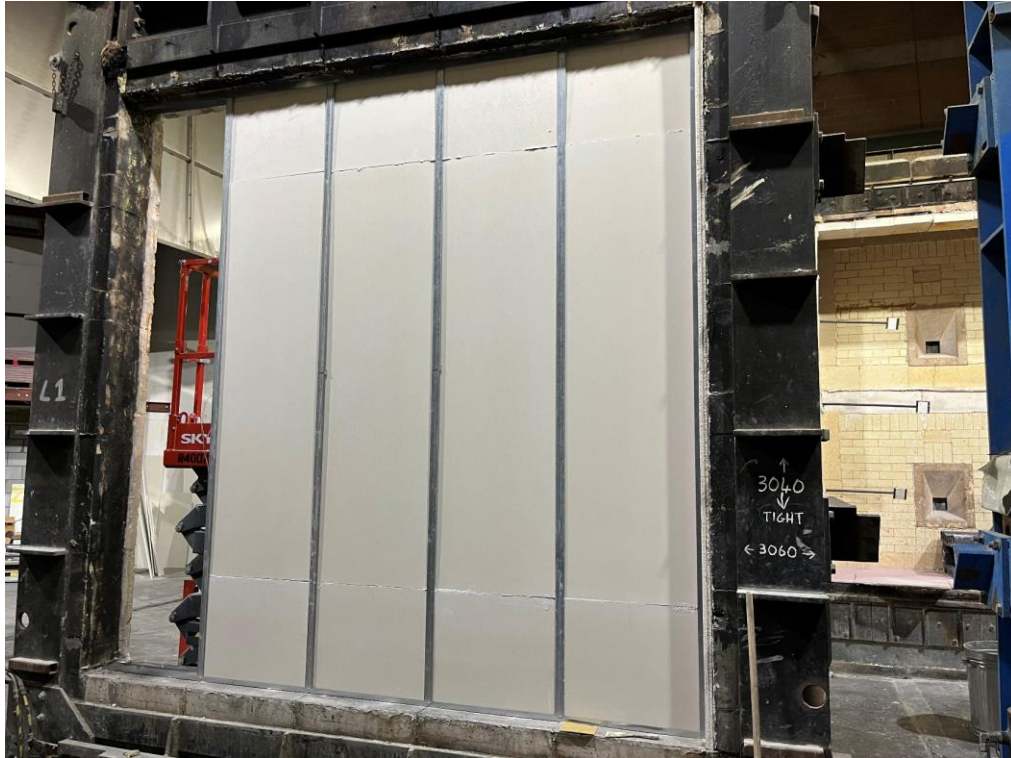
Photo 1 - Specimen During construction – Unexposed side

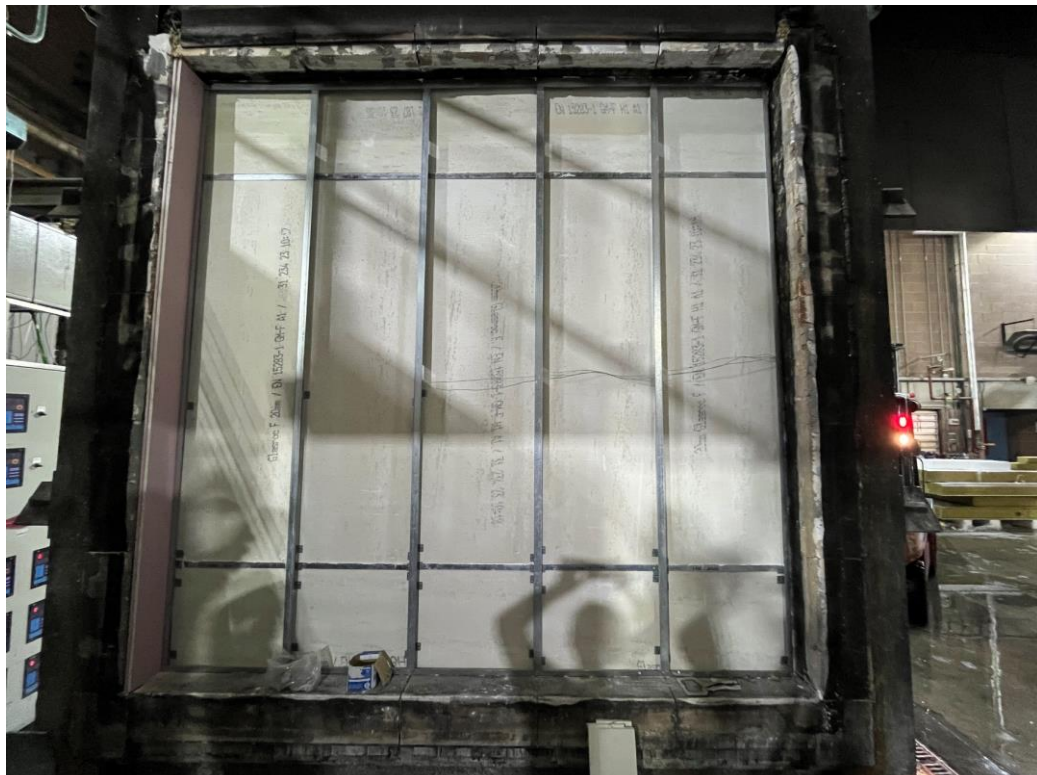
Photo 2 - Specimen during construction - Unexposed side boarding view from exposed side. Note the angles on the horizontal joints.

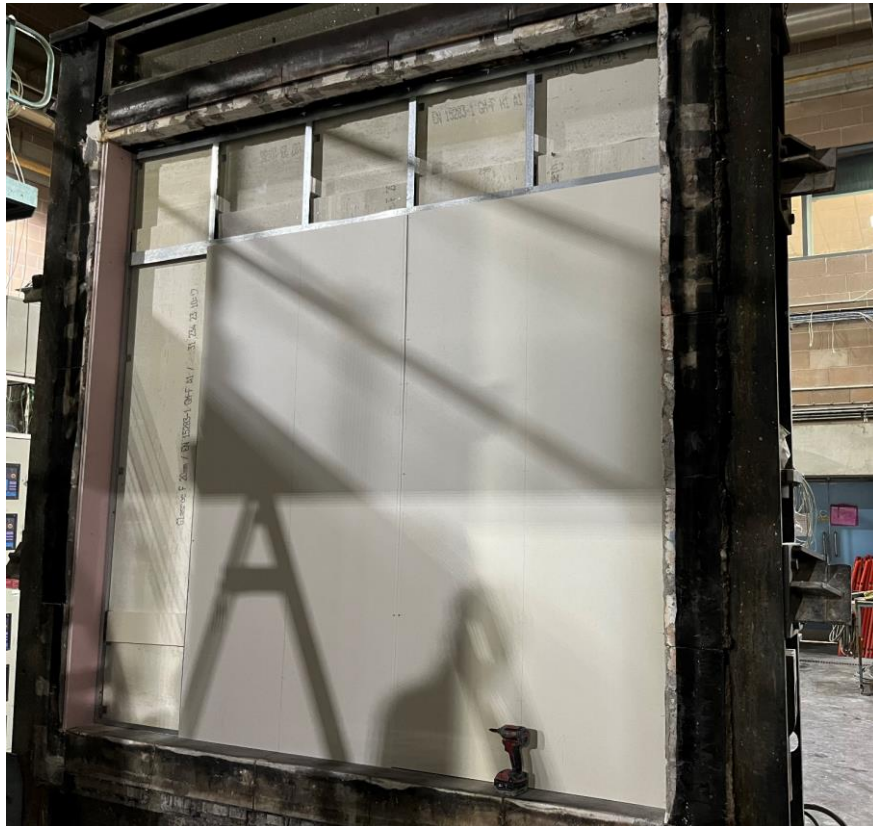
Photo 3 - Specimen during construction - Exposed side boarding – first layer. Note the boards over the angles on the horizontal joints.

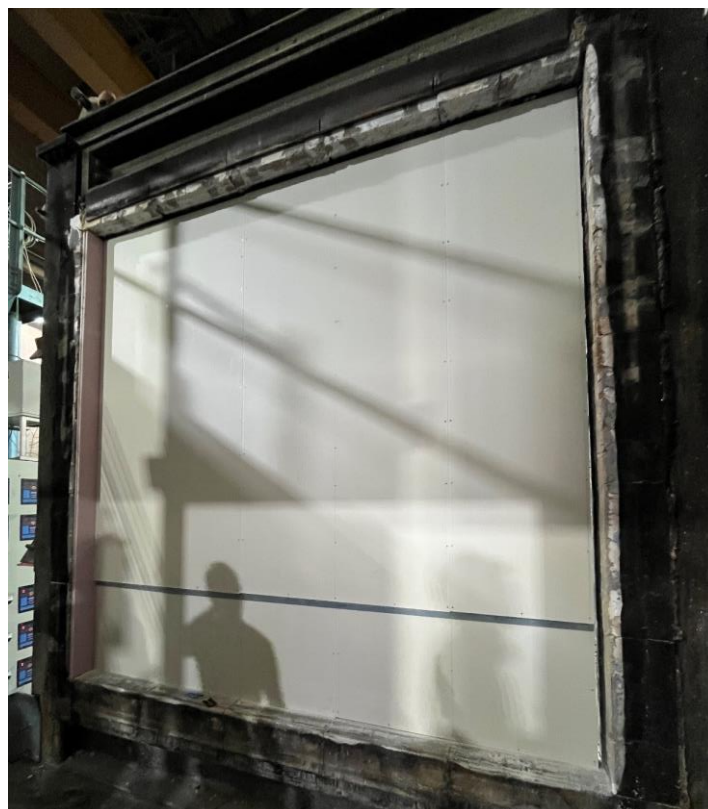
Photo 4 – Second layer of boarding on the exposed side

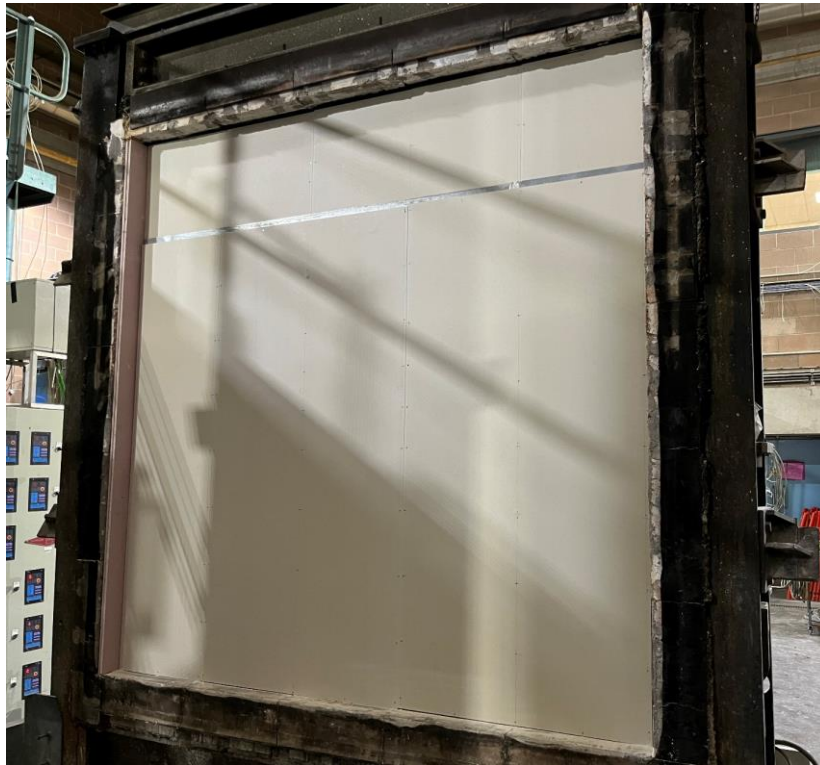
Photo 5 -Third layer of boarding on the exposed side

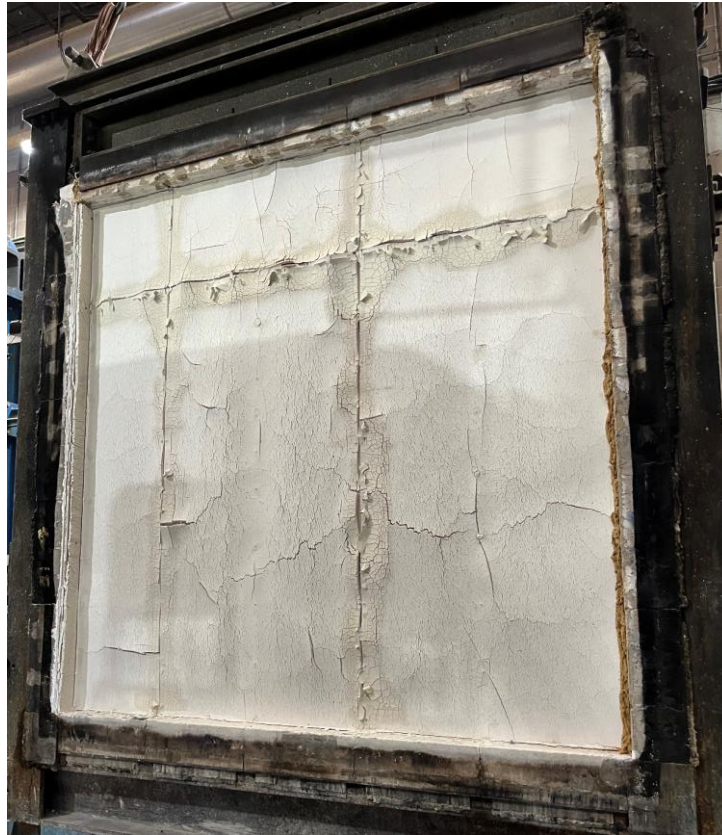
Photo 13 - Exposed side of the specimen after the test

All boards are in place.

See Photos 13 and 14, Appendix D.

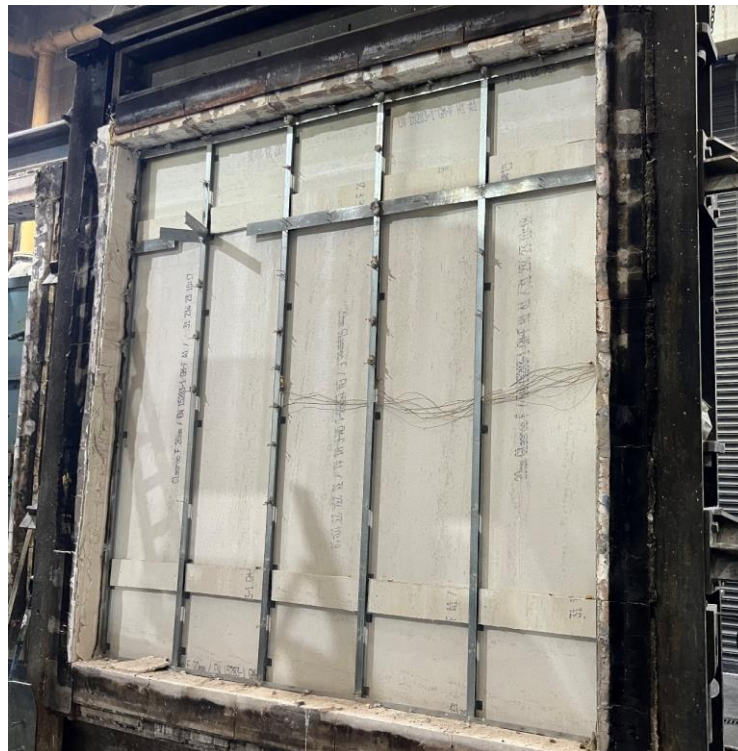
Photo 14 - Exposed side of the specimen during dismantling
